CONSTRUCTION MONITORING REPORT

[OCTOBER 2024 TO APRIL 2025]

Errant and Hostile Vehicle Mitigation
Treatments for the Southwest Metro Project
SMC-22-0722

SMCSWSW7-MRL-1NL-
EM-REP-001090

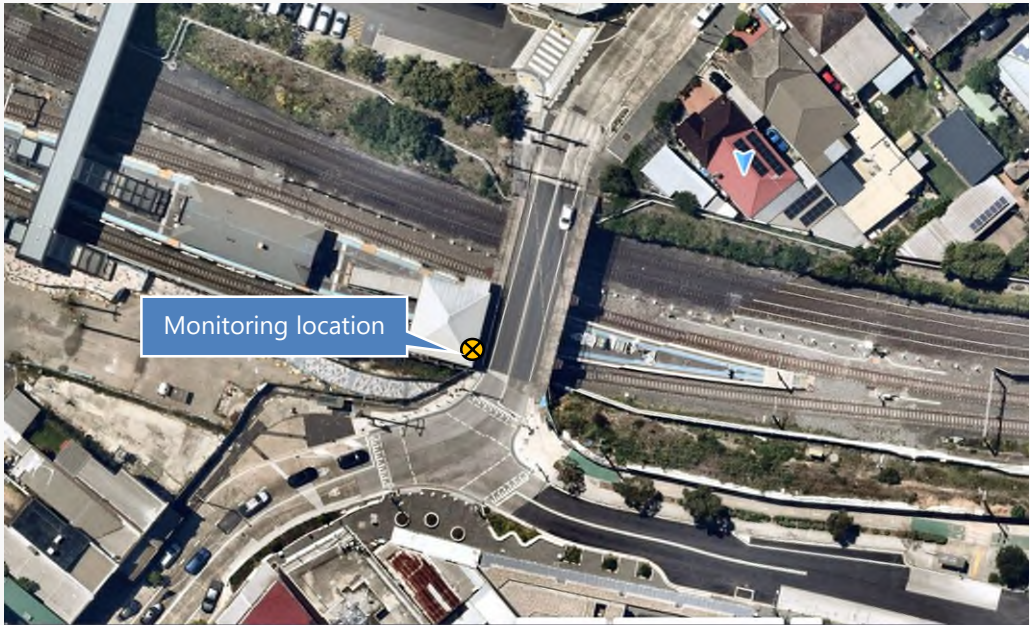
Monitoring location

Baseline vibration monitoring was conducted when there were no construction activities occurring on 6th January 2025. All measured vibration levels were below 7.5 mm/s when there were no construction activities occurring.

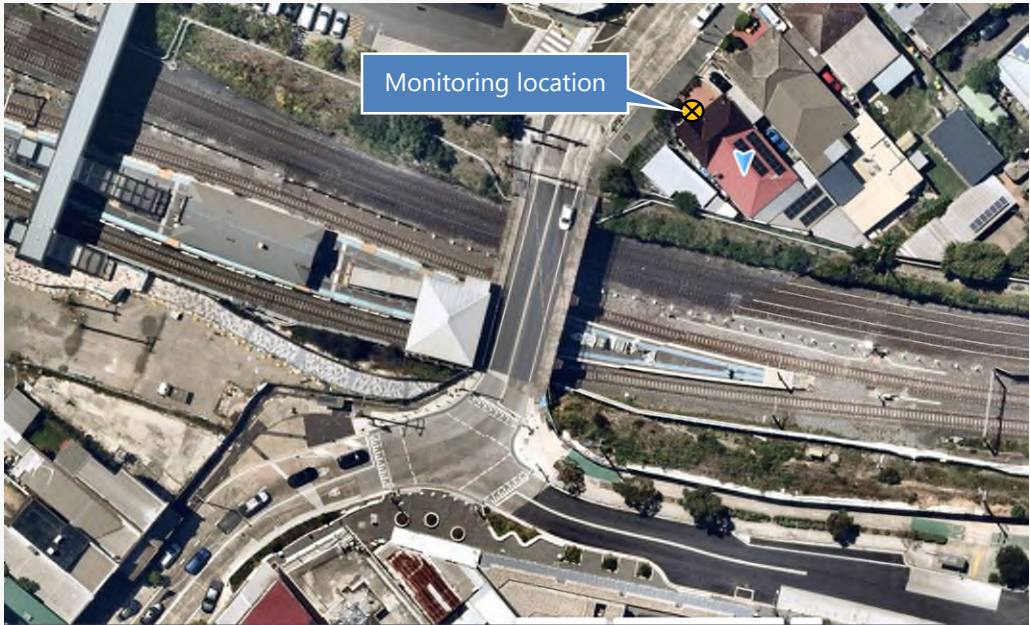
Monitoring location

Baseline vibration monitoring was conducted when there were no construction activities occurring on 6th January 2025. All measured vibration levels were below 7.5 mm/s when there were no construction activities occurring.

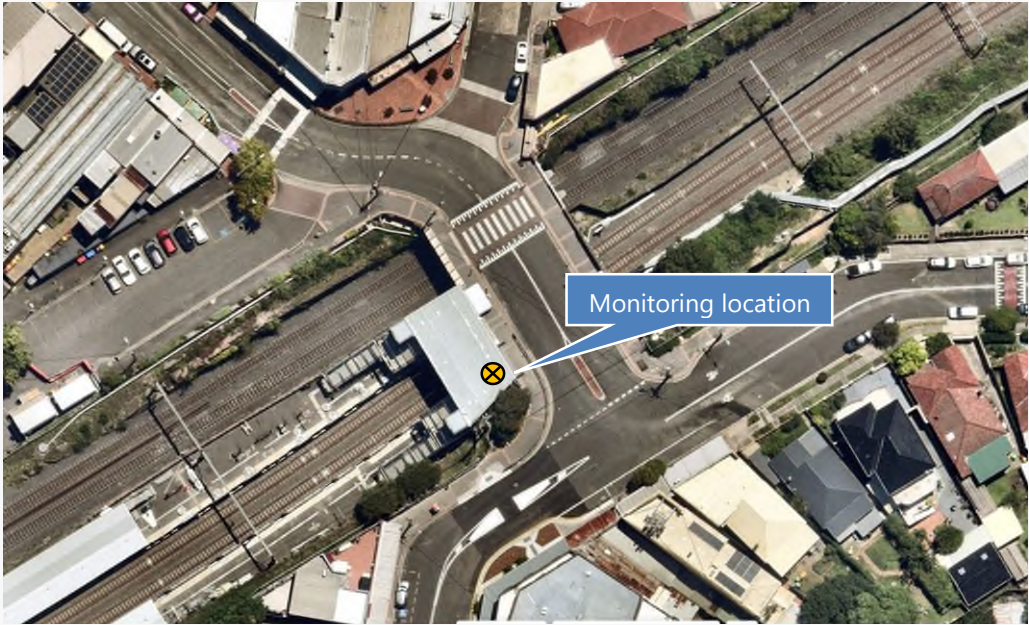
Monitoring location

Baseline vibration monitoring was conducted when there were no construction activities occurring on 7th January 2025. All measured vibration levels were below 7.5 mm/s when there were no construction activities occurring.

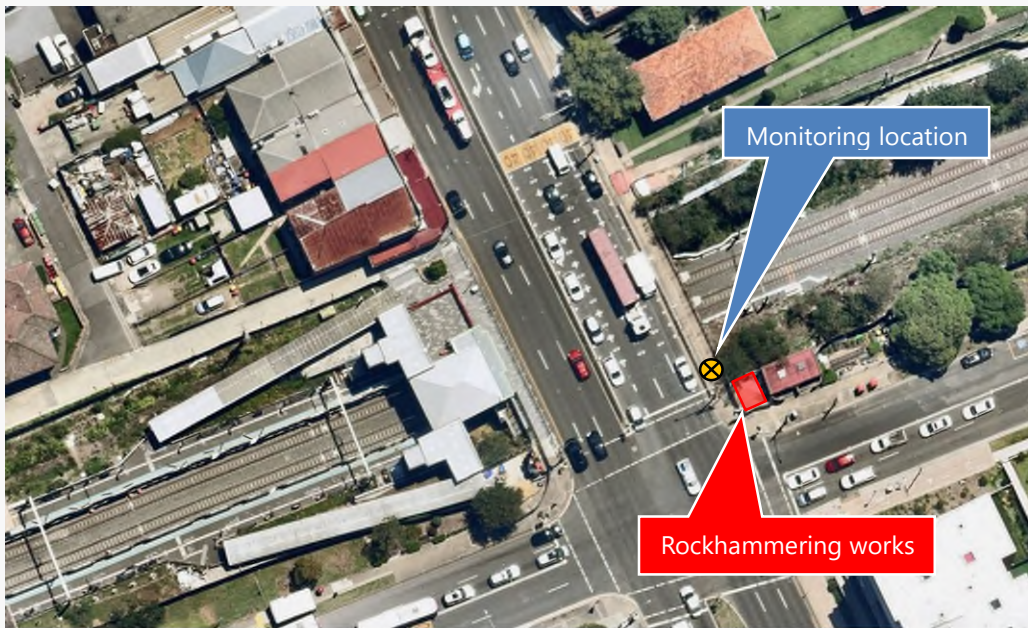
Comments		
Vibration monitoring was conducted during the rockhammering works on 16 th January 2025. Based on the results shown below, the works produced vibration levels below the screening criterion of 7.5 mm/s. Therefore, the vibration monitoring confirms compliance with the NVMP vibration limits.

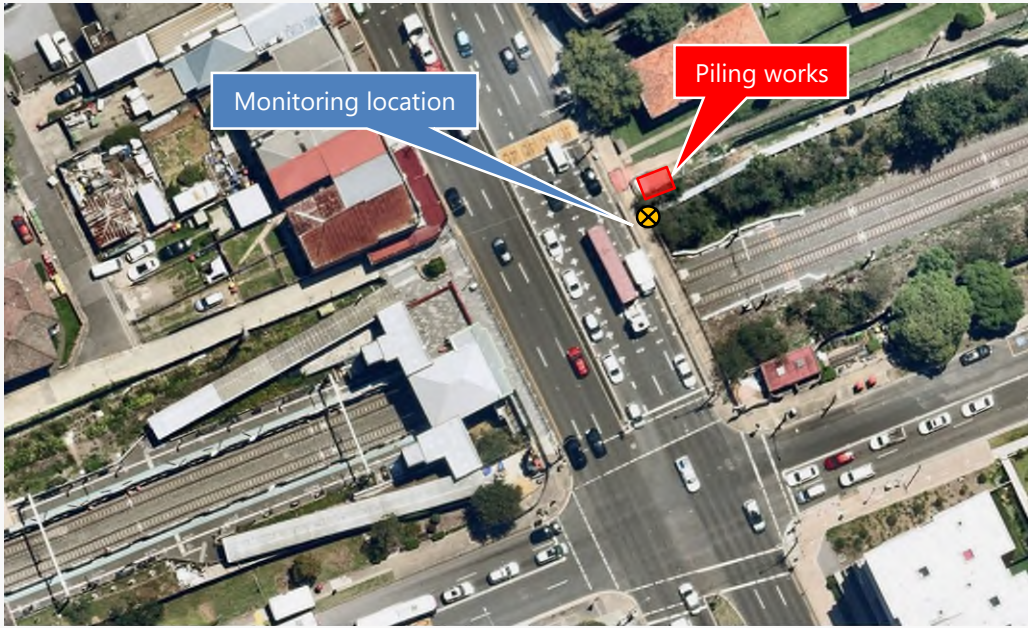
Comments	
Vibration monitoring was conducted during the piling works on 21 st January 2025. Based on the results shown below, the works produced vibration levels below the screening criterion of 7.5 mm/s. Therefore, the vibration monitoring confirms compliance with the NVMP vibration limits.

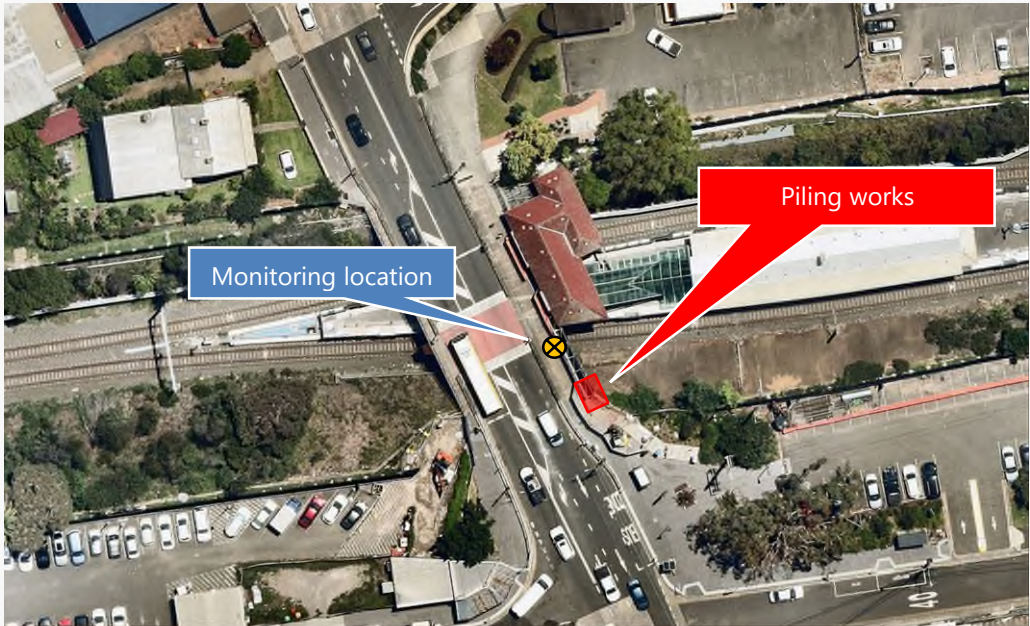
Monitoring location

Vibration monitoring was conducted during the piling works on 28th January 2025. Based on the results shown below, the works produced vibration levels below the screening criterion of 7.5 mm/s. Therefore, the vibration monitoring confirms compliance with the NVMP vibration limits.

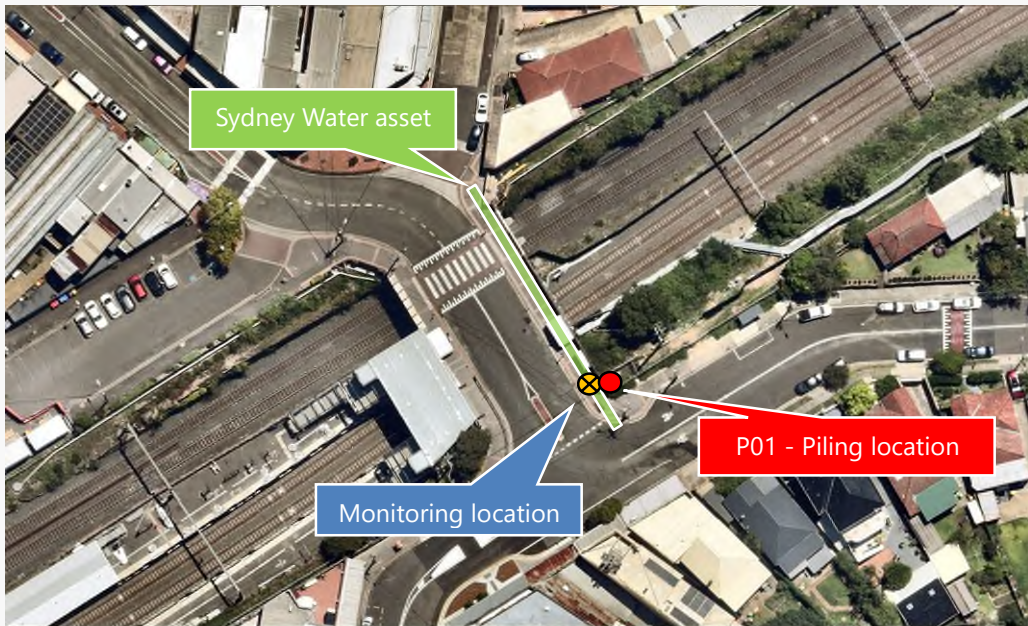
Comments		
Vibration monitoring was conducted during the piling works on 20 th February 2025. Based on the results below, the works produced vibration levels below the screening criterion of 5 mm/s at 1m away.

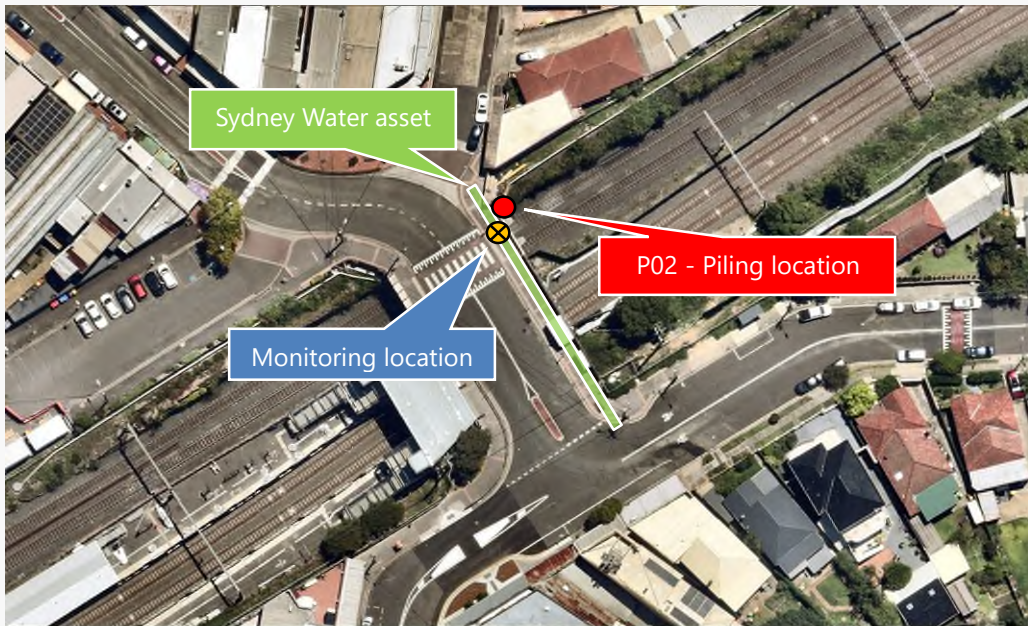
Comments		
Vibration monitoring was conducted during the piling works on 27 th February 2025. Based on the results below, the works produced vibration levels below the screening criterion of 5 mm/s at 3m away.
