## HERITAGE MANAGEMENT PLAN

# Sydney Metro SWM4

Design and Construction of  
Errant and Hostile Vehicle  
Mitigation Treatments for  
the Southwest Metro Project

PROJECT DOCUMENT NUMBER: MR-  
EHVMT-EE-03

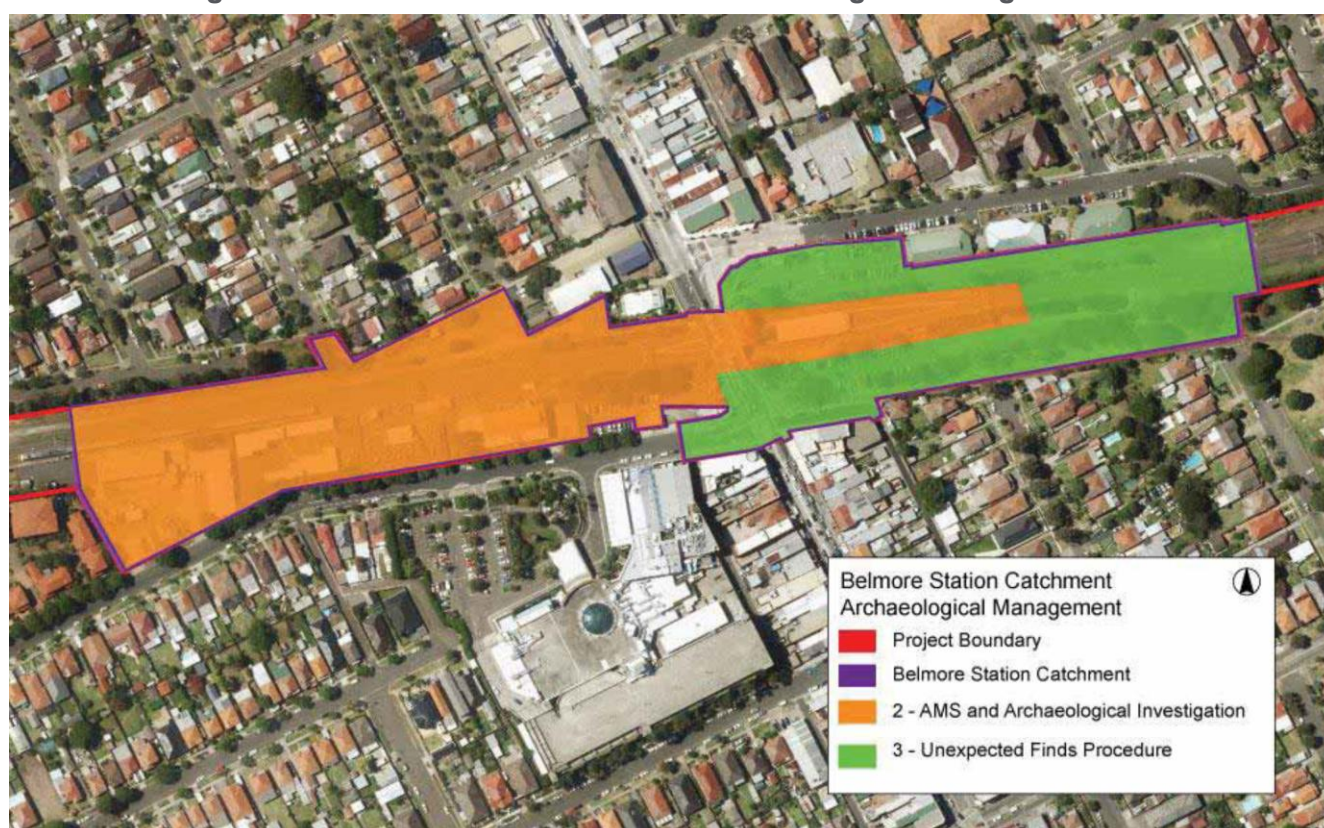
Figure 5: Belmore Station Catchment Archaeological Management Zones

Archaeological management zone mapping depicted at Marrickville and Belmore (Figure 4 and Figure 5) is based on a 'traffic light' coding:

Archaeological management will be undertaken in accordance with the works specific AMS documents and in accordance with the archaeological management zoning and AARD (refer to Figure 4 and Figure 5).

An AMS will be prepared for the Project prior to sub-surface impacts within Red (Zone 1) and Amber (Zone 2) archaeological management zones as mapped in Figure 4 and Figure 5.

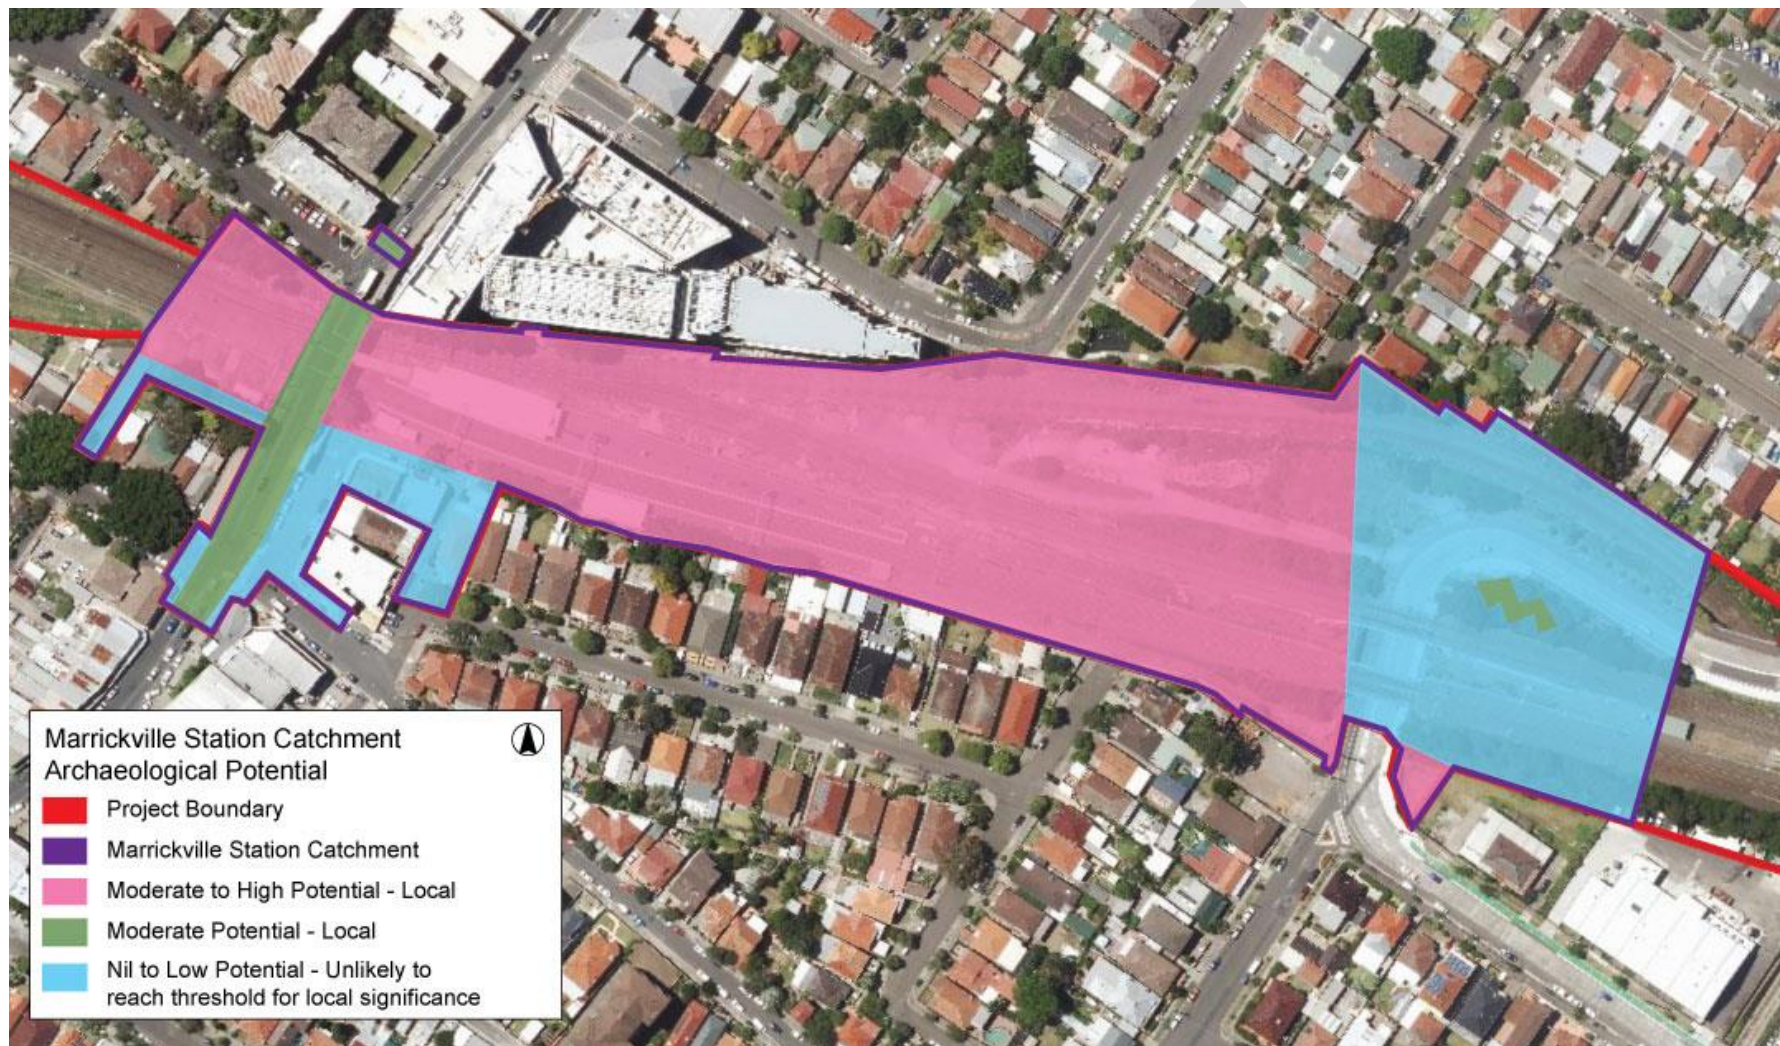
Figure 21: Archaeological potential for Marrickville Station Catchment<sup>11</sup>

The AARD predicted archaeological remains of local significance to be present at Marrickville Station. A summary of the archaeological potential and significance of predicted remains is provided in Table 2 and the location of these archaeological resources is provided in Figure 21.

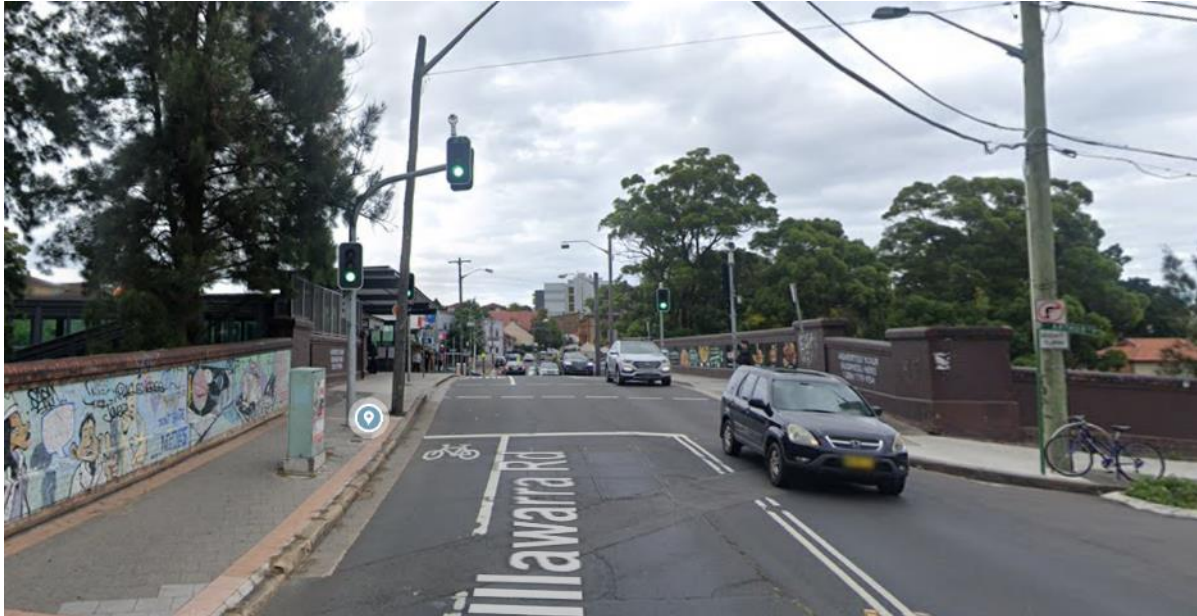
Figure 32: Illawarra Road Bridge (Source: Google maps)

The Illawarra Road Bridge, which runs northeast- southwest above Marrickville Station consists of steel girders and a concrete slab supported on central brick piers and side brick abutments.<sup>28</sup> The existing barriers between the road and the rail corridor consist of painted brick parapet walls with steel mesh throw screens fixed to the top of the parapet walls on the eastern side of the road. The kerbing along the bridge consists of modern concrete sections and earlier sections of trachyte and sandstone.

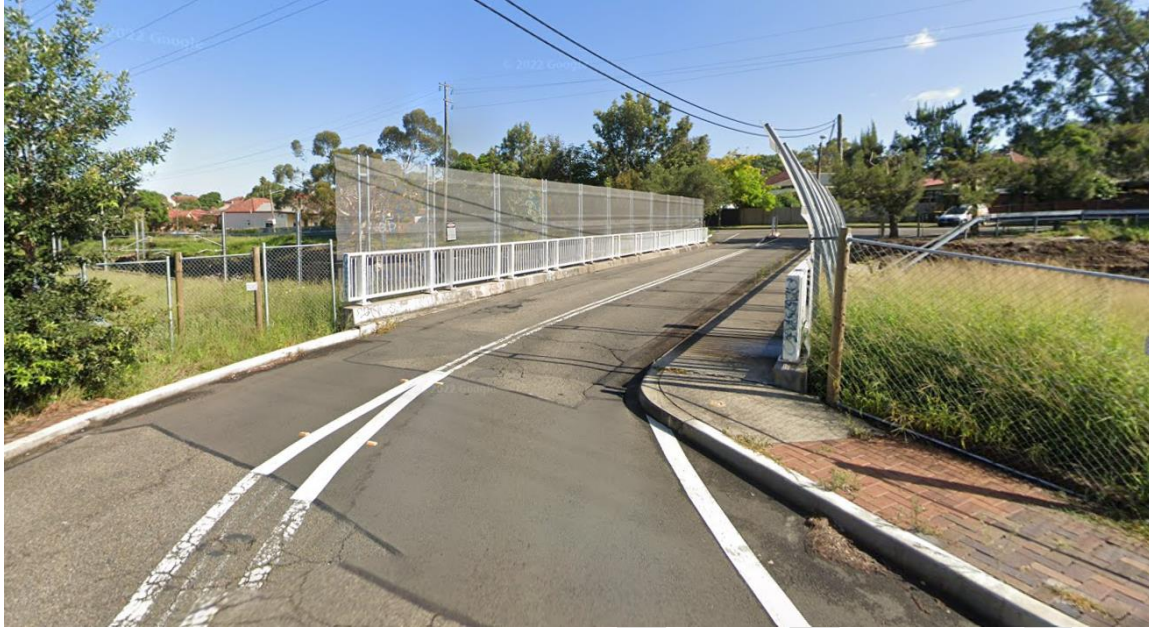
Albermarle Street Overbridge consists of a concrete road deck atop girders which span between the embankments on either side of the rail corridor. The girders are supported by metal piers. A metal balustrade and safety fence line each side of the road deck. The brick footpath on the eastern side of Albermarle Street is part of the extensive brick paving that was laid in the Great Depression as part of the Employment Relief Schemes in the 1930s.

Figure 34: Albermarle Street Overbridge, with Depression era brick paving visible on the right (east) side (Source: Google Maps)

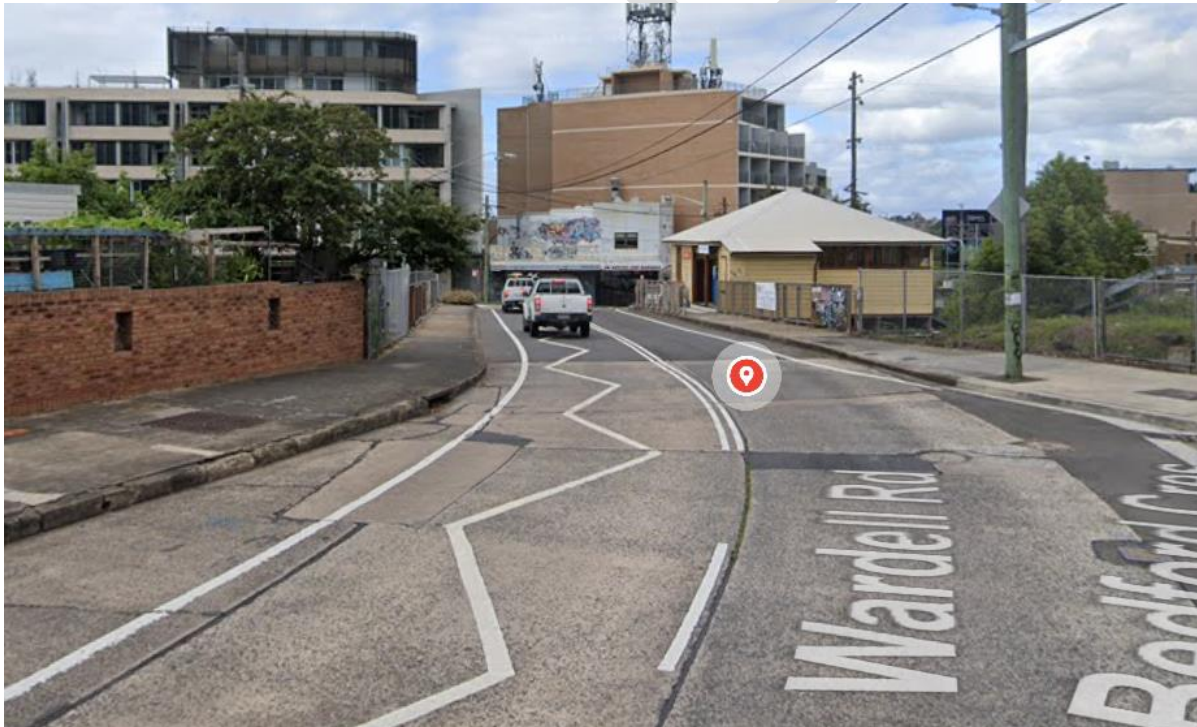
Figure 36: Wardell Road Overbridge (Source: Google maps)

The Wardell Road Overbridge consists of a modern, pre-stressed concrete road deck spanning between lateral concrete beams. These beams bear on the original face brick platform and the embankment piers on each side.<sup>33</sup>

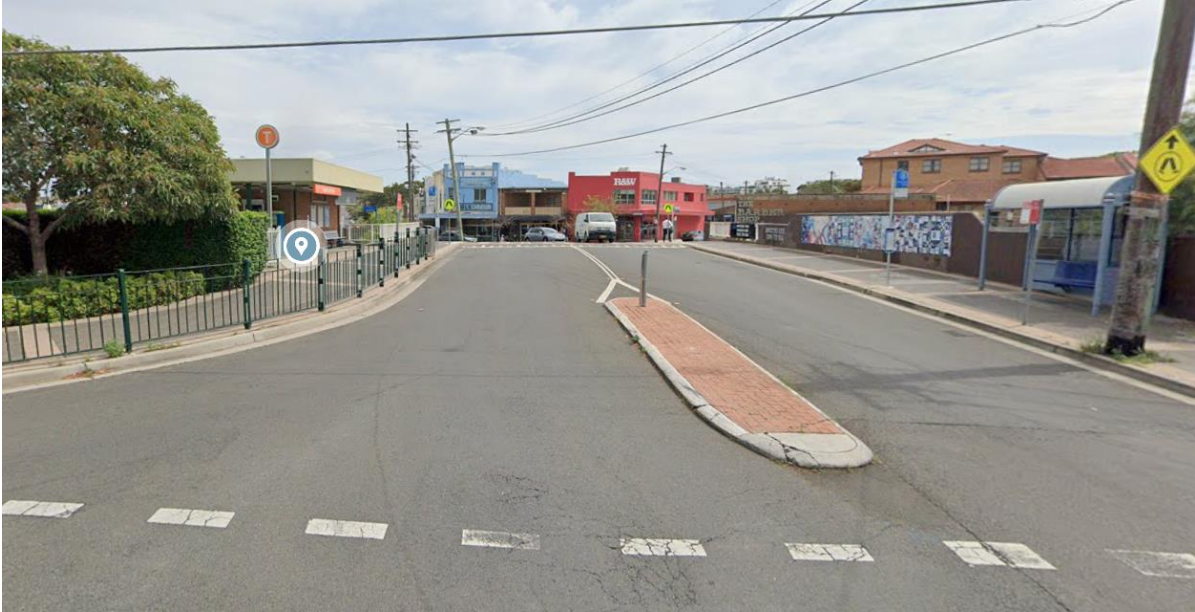
Figure 38: Duntroon Street Bridge (Source: Google Maps)

The Hurlstone Park overbridge consists of steel girders supported on face brick embankments and central brick piers, and modern balustrading.<sup>36</sup>

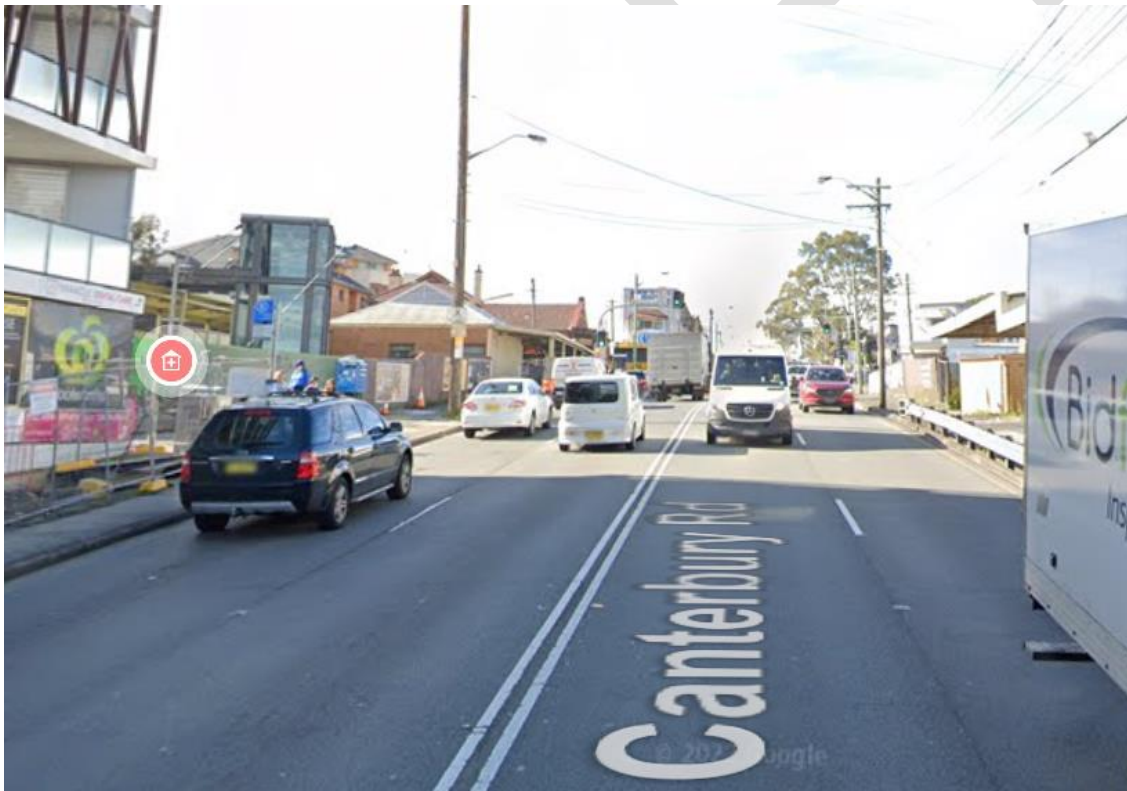
Figure 40: Canterbury Road Bridge (Source: Google maps)

The Canterbury Road Bridge consists of a jack arched brick and concrete deck support by steel girders. The girders are supported by concrete and brick abutments and span the Up and Down Line. The parapet walls lining the road deck are brick.

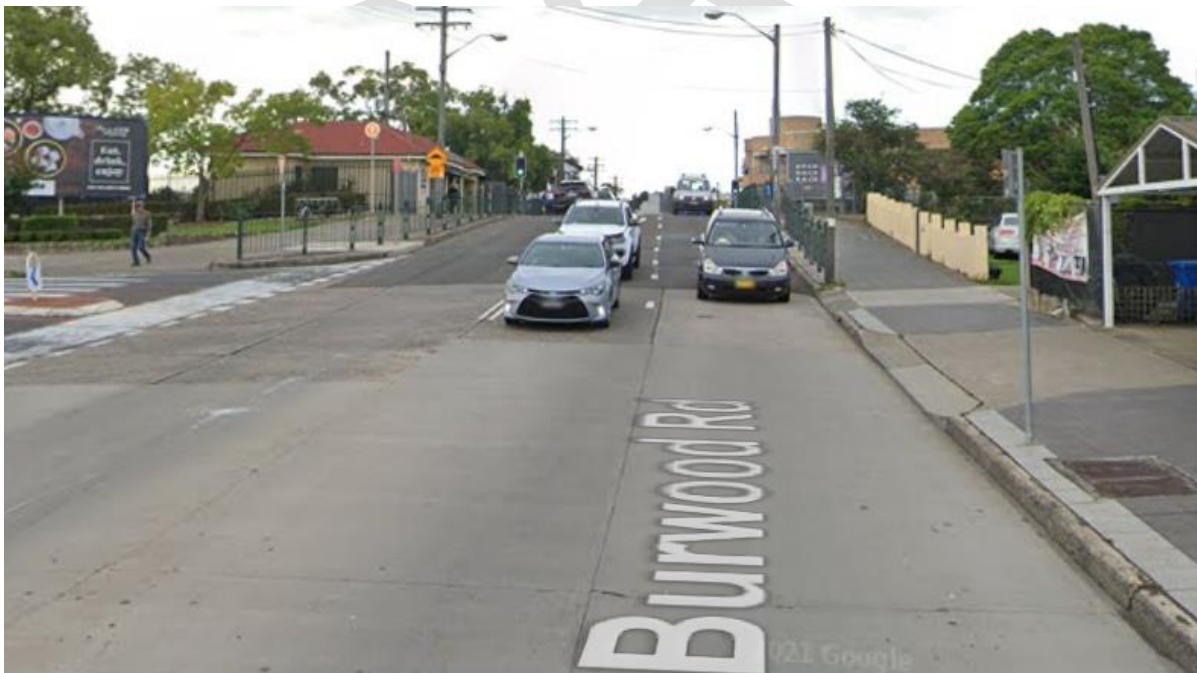
Figure 42: Burwood Road Bridge (Source: Google maps)

The Burwood Road Bridge consists of a prestressed concrete road deck, support by concrete abutments on either side and a central brick pier which was part of the original overbridge.<sup>42</sup> The existing barriers between the road and the rail corridor are steel mesh screens fixed to the concrete pavement.

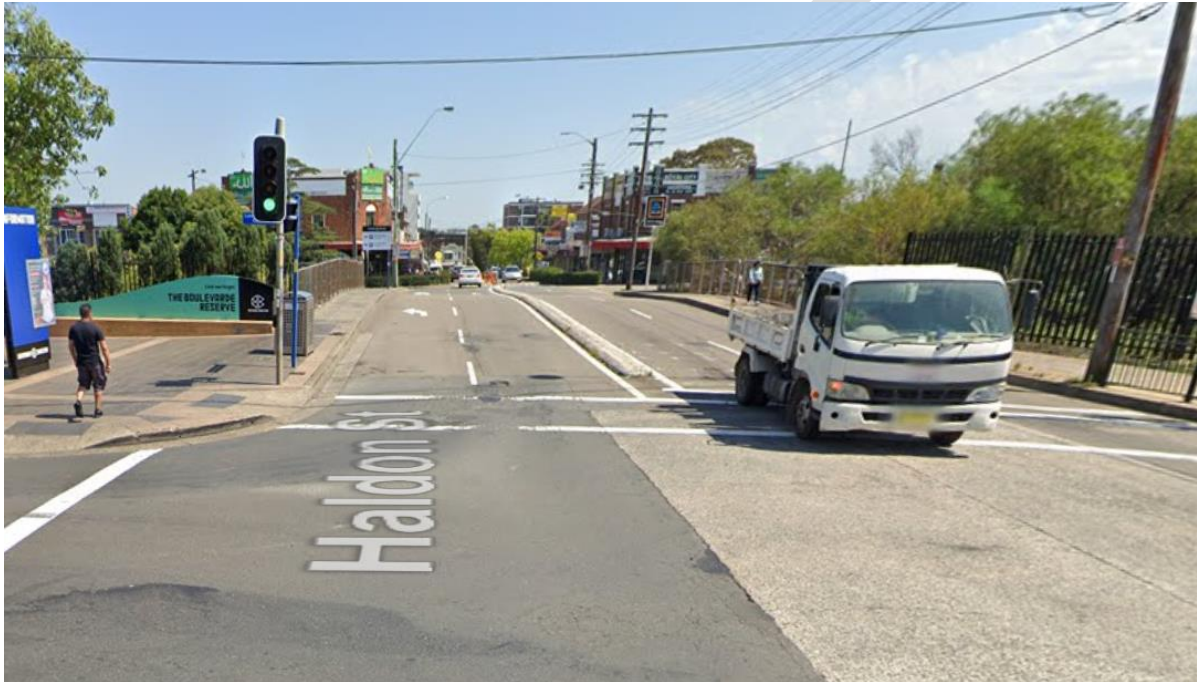
Figure 44: Haldon Street Bridge (Source: Google maps)

Haldon Street overbridge is a two span concrete girder structure, stretching approximately 27m.

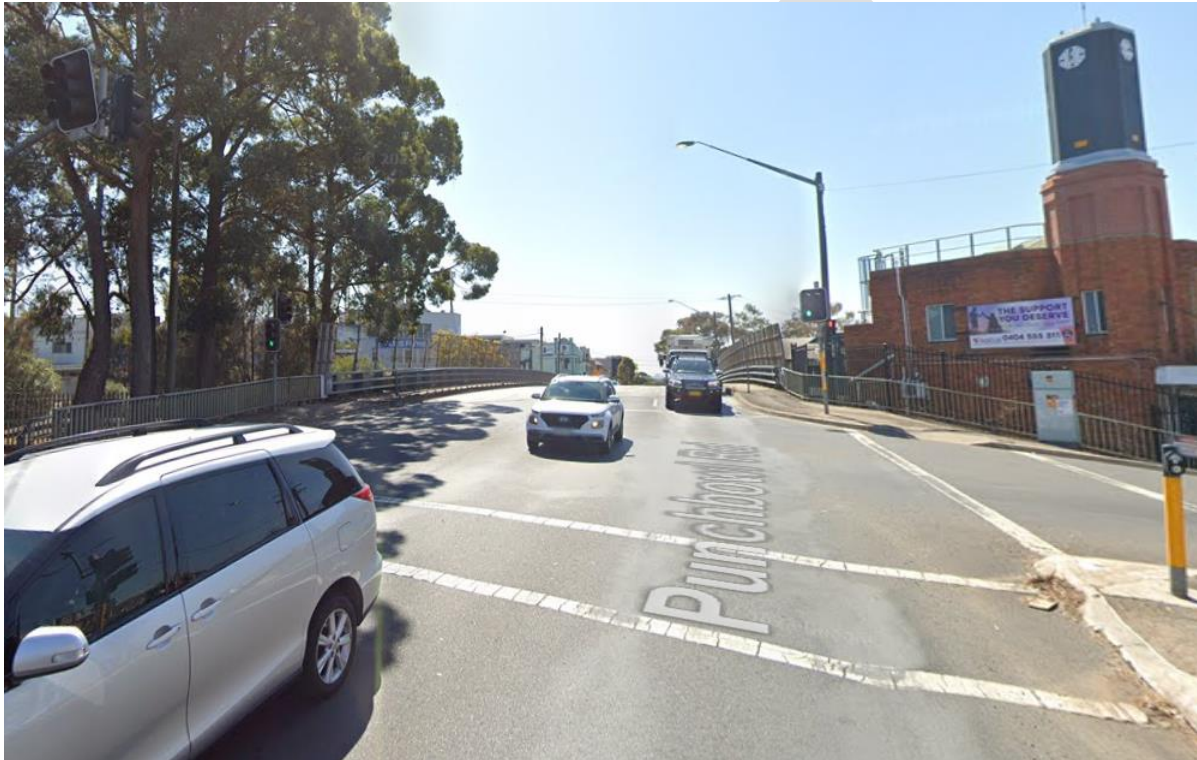
Figure 46: Punchbowl Road Bridge (Source: Google Maps)

Punchbowl Road overbridge, constructed in 1979, is a two span concrete girder bridge spanning approximately 48 metres.<sup>47</sup>

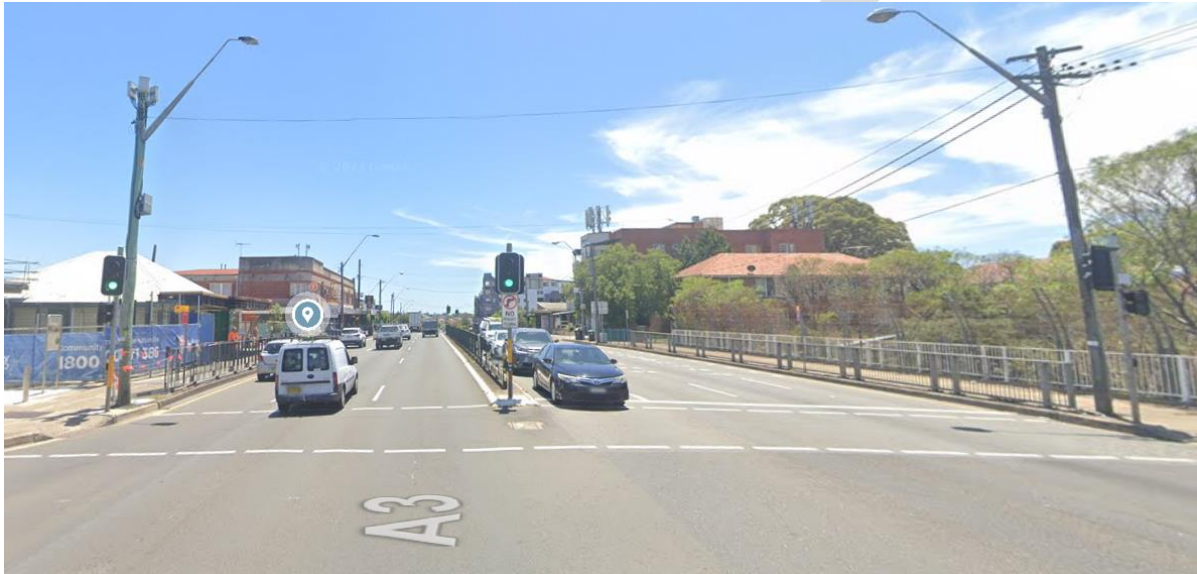
Figure 48: King Georges Road Bridge (Source: Google Maps)

The King Georges overbridge is a three span concrete girder structure spanning approximately 31 metres.<sup>51</sup>

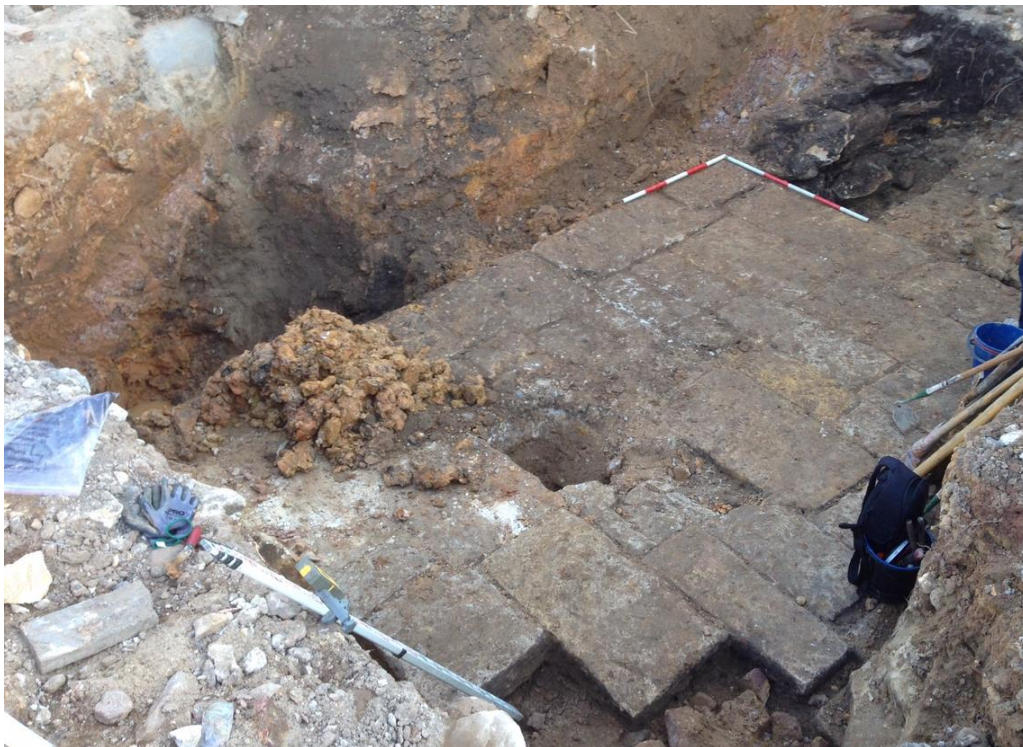
Photo 4 Sandstone pavers uncovered at Balmain East, 2016

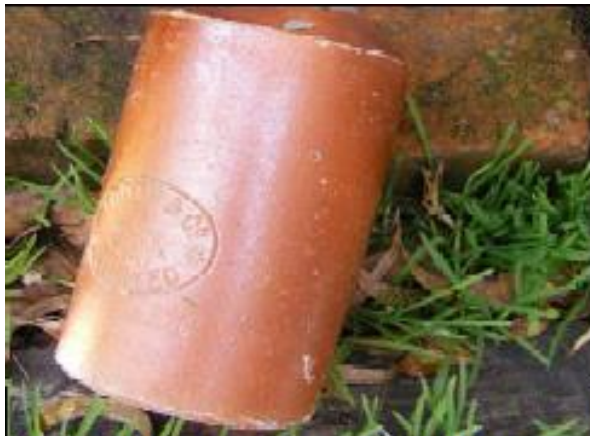
Figure 3: Ceramic bottle artefact with stamp.

Where unexpected items have a distinguishing feature, close up detailed photographs must be taken of these features, where practicable. In the case of a building or bridge, this may include diagnostic details architectural or technical features. See Figures 3 and 4 for examples.

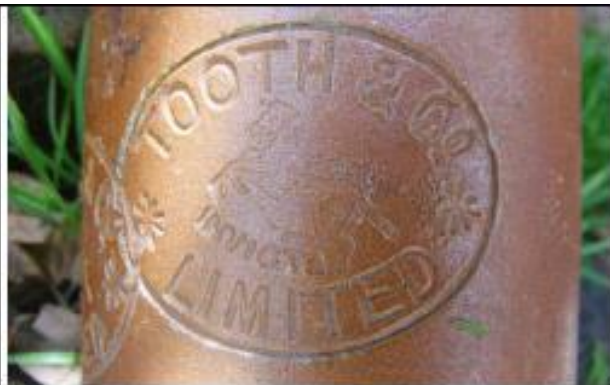
Figure 4: Detail of the stamp allows 'Tooth & Co Limited' to be made out. This is helpful to a specialist in gauging the artefact's origin, manufacturing date and likely significance.
