CONSTRUCTION MONITORING REPORT

[OCTOBER 2024 TO APRIL 2025]

Errant and Hostile Vehicle Mitigation
Treatments for the Southwest Metro Project
SMC-22-0722

SMCSWSW7-MRL-1NL-
EM-REP-001090

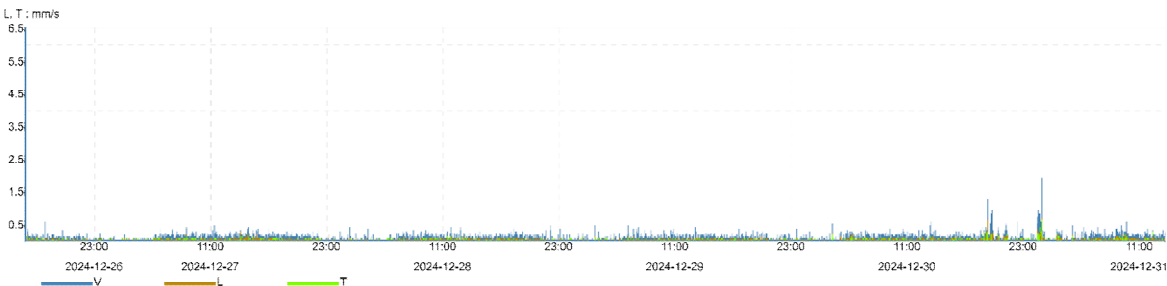
Figure B.1: 26.12.2024 – 31.12.2024 unattended vibration monitoring results (all axes)

Date and Time	Distance (m)	Plant operating	Measured peak particle velocity (ppv), mm/s						Vibration criterion
			X-axis		Y-axis		Z-axis		
			95 th percentile	Maximum ppv	95 th percentile	Maximum ppv	95 th percentile	Maximum ppv	ppv (mm/s)
M1									
26.12.2024 – 31.12.2024 02:42pm – 02:38pm	15-25m	Bored piling rig	0.3	2.50	0.10	0.95	0.10	0.70	7.5 mm/s

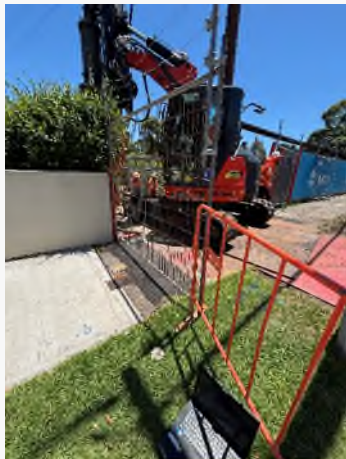
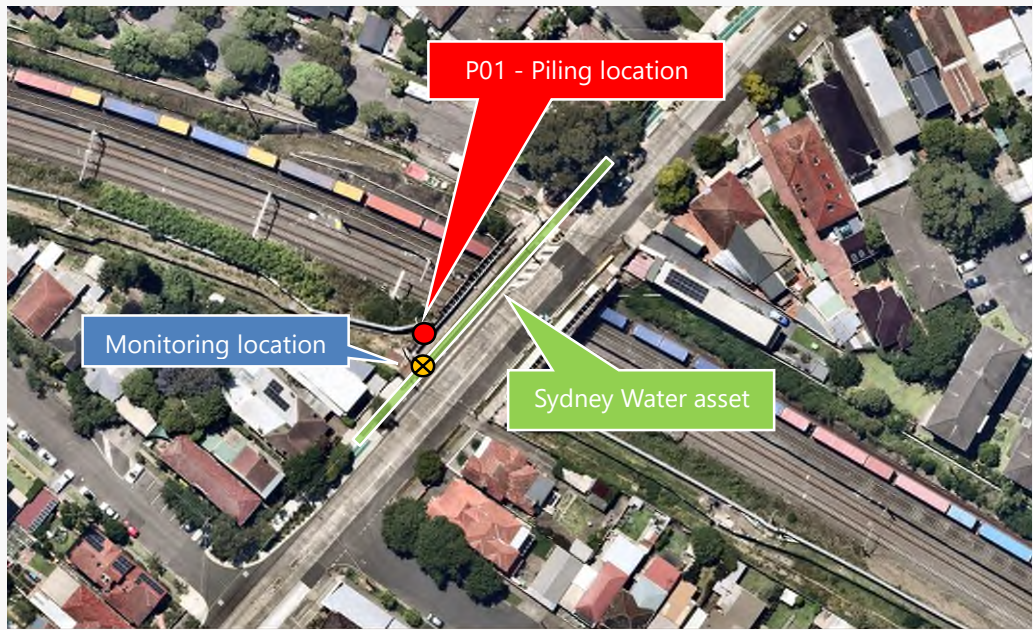
B.1 Livingstone Rd Overbridge P01 piling works vibration monitoring

Vibration monitoring was conducted during the piling works on 17th December 2024. Based on the results shown below, the works produced vibration levels below the screening criterion of 5 mm/s at 2.5m away.

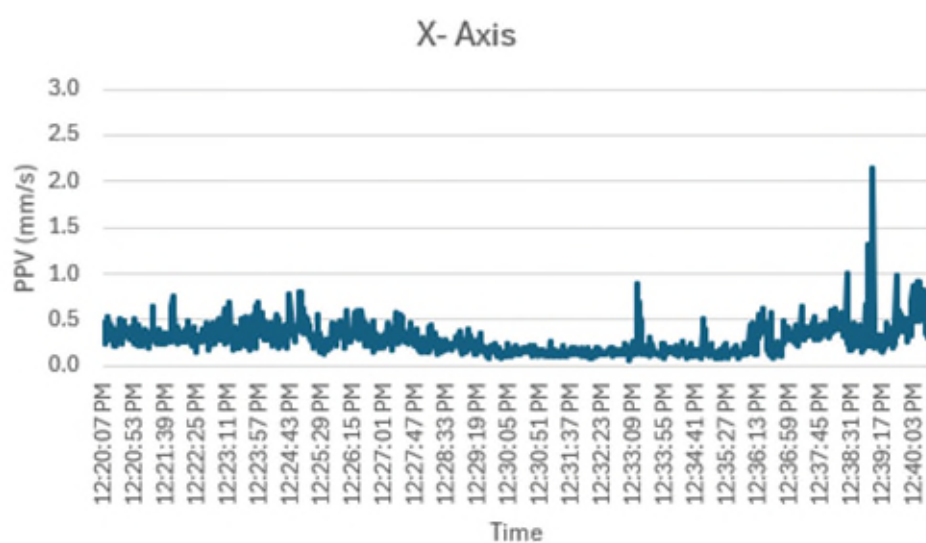
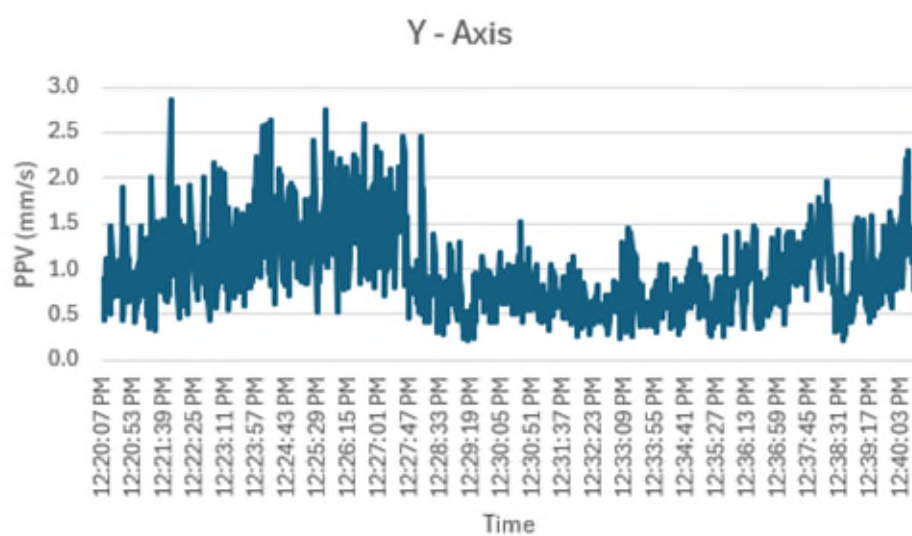
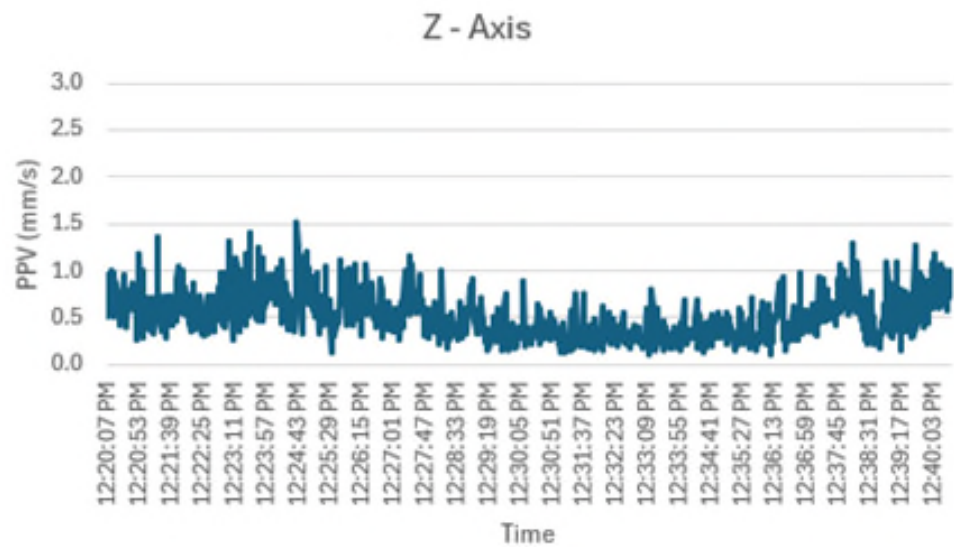
Figure B.1: 17.12.2024 measured vibration levels from all P01 works (X-Axis)

Date and Time	Distance (m)	Plant operating	Measured peak particle velocity (ppv), mm/s						Vibration limits
			X-axis		Y-axis		Z-axis		ppv (mm/s)
			Frequency (Hz)	Maximum ppv	Frequency (Hz)	Maximum ppv	Frequency (Hz)	Maximum ppv	
M2									
17.12.2024 12:21pm – 12:46pm	2.5m	MRC 1.2t Bored piling rig	5	2.20	5	2.86	4	1.51	5 mm/s 10 mm/s

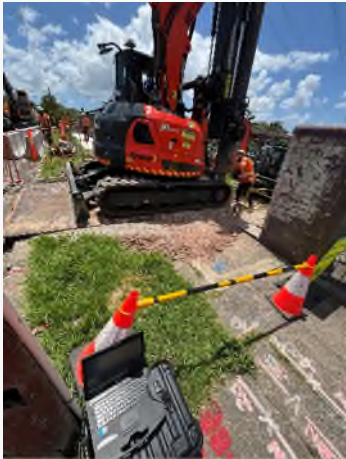
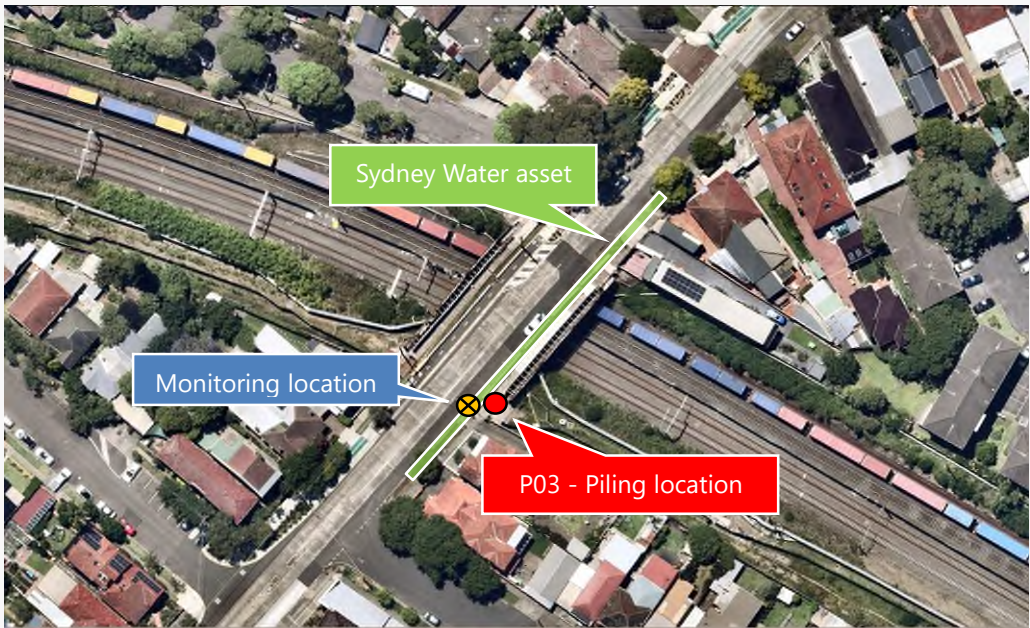
B.2 Livingstone Rd Overbridge P03 piling works vibration monitoring

Vibration monitoring was conducted during the piling works on 19th December 2024. Based on the results below, , the works produced vibration levels below the screening criterion of 5 mm/s at 3.5m away.

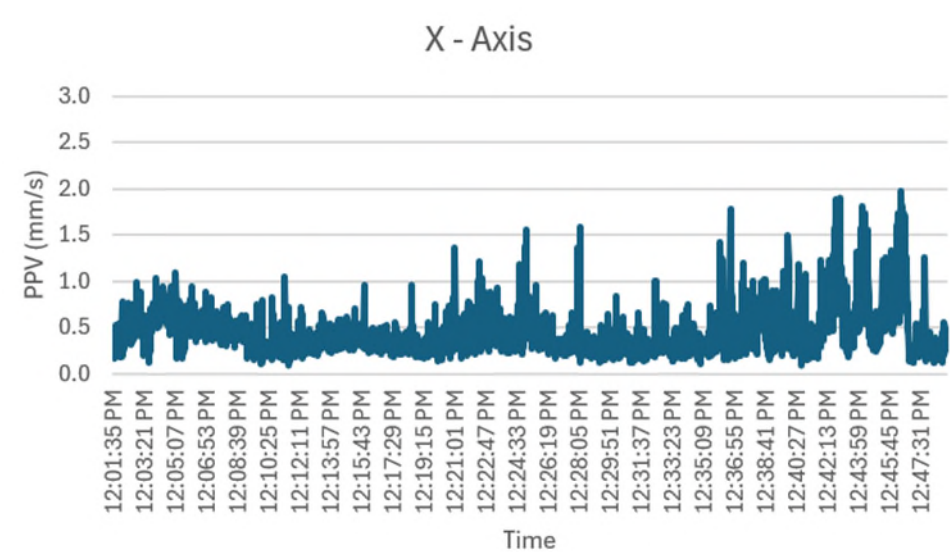
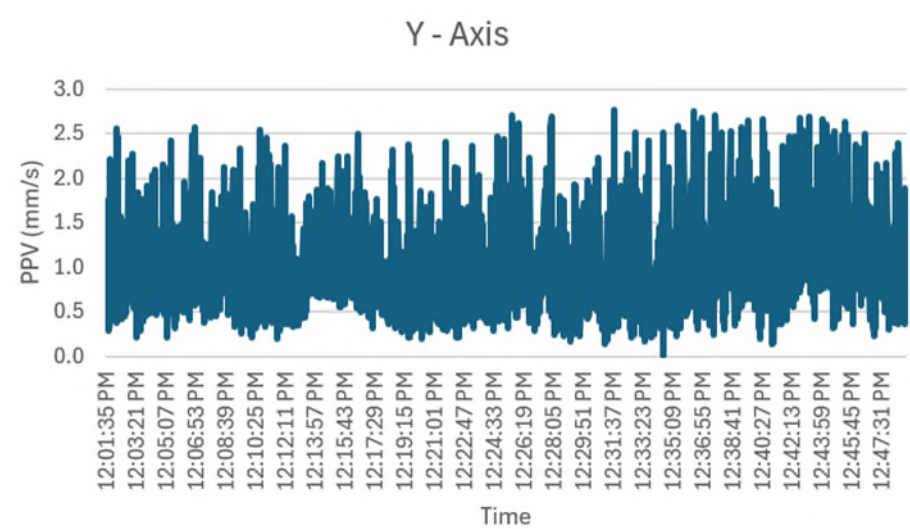
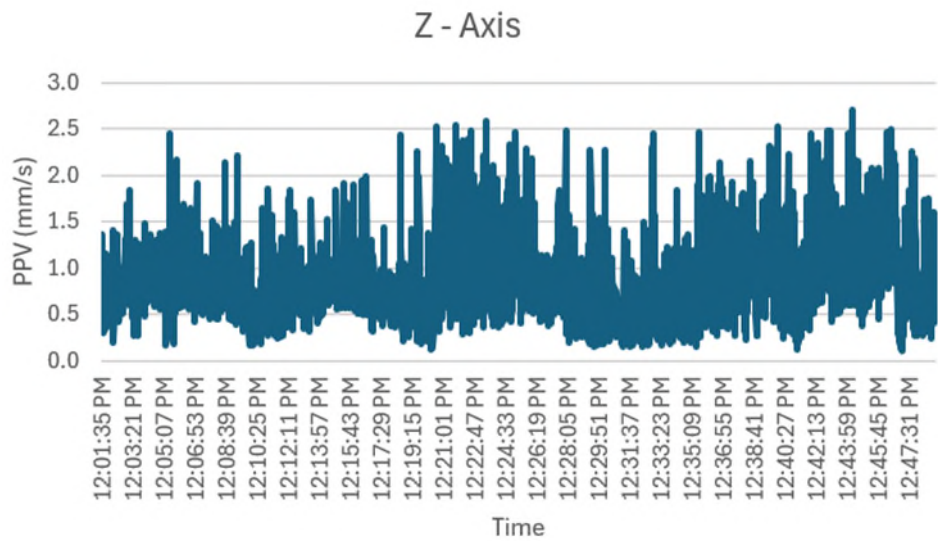
Figure B.2: 19.12.2024 measured vibration levels from all P03 works (X-Axis)

Date and Time	Distance (m)	Plant operating	Measured peak particle velocity (ppv), mm/s						Vibration criteria
			X-axis		Y-axis		Z-axis		
			Frequency (Hz)	Maximum ppv	Frequency (Hz)	Maximum ppv	Frequency (Hz)	Maximum ppv	ppv (mm/s)
M3									
19.12.2024 12:01pm – 12:49pm	3.5m	MRC 1.2t Bored piling rig	5	2.01	5	2.68	4	2.45	5 mm/s 10 mm/s

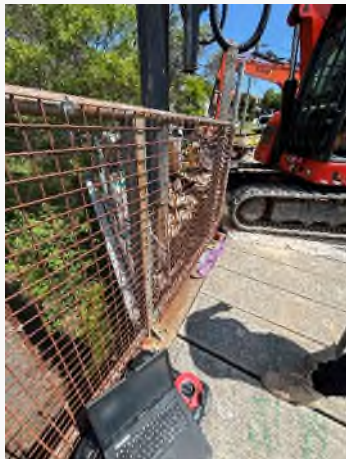
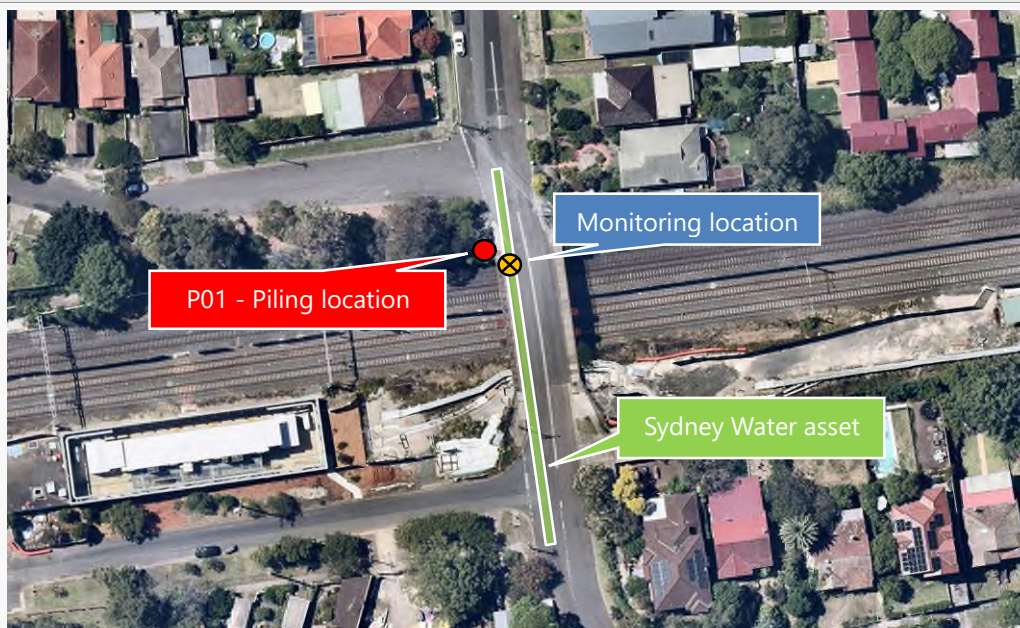
B.3 Melford Street Overbridge P01 piling works vibration monitoring

Baseline vibration monitoring shows that vibration levels were below 5 mm/s when there were no construction activities occurring on site. Vibration monitoring was conducted during the piling works on 13th January 2025. Based on the results below, the works produced vibration levels below the screening criterion of 5 mm/s at 3.5m away.

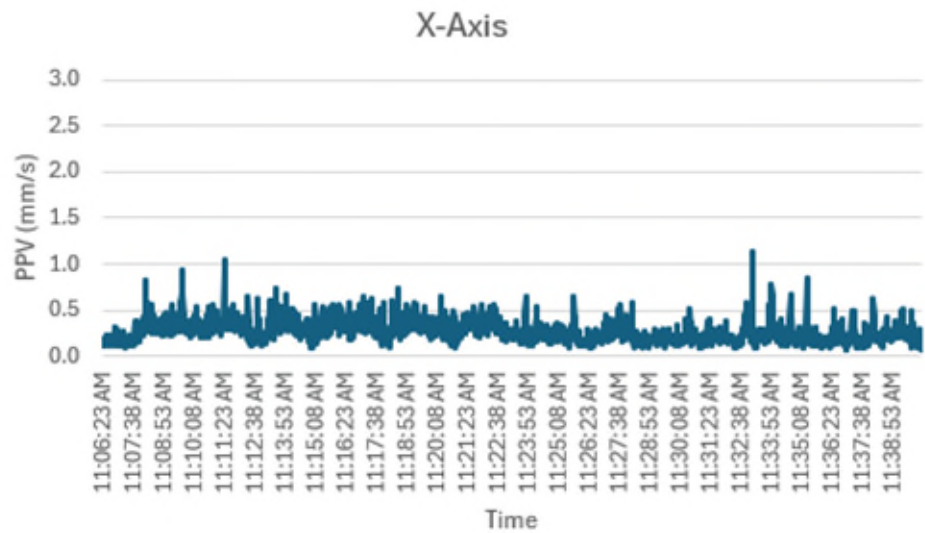
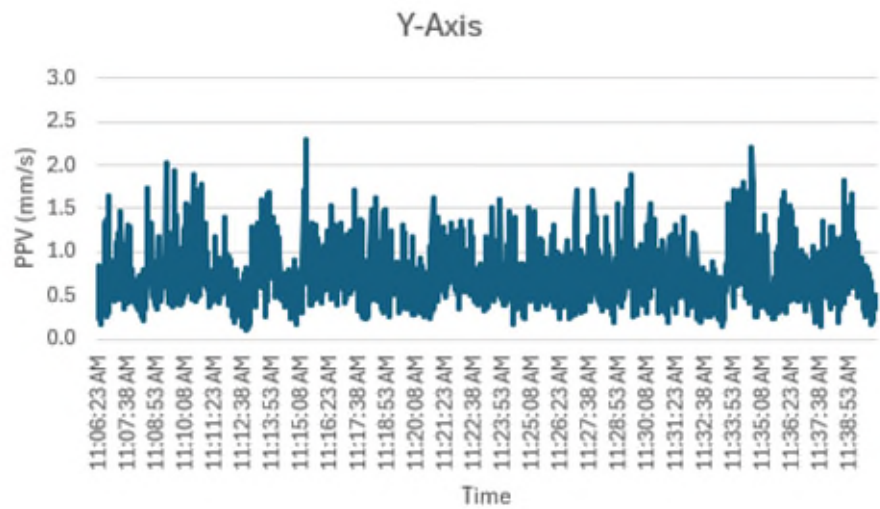
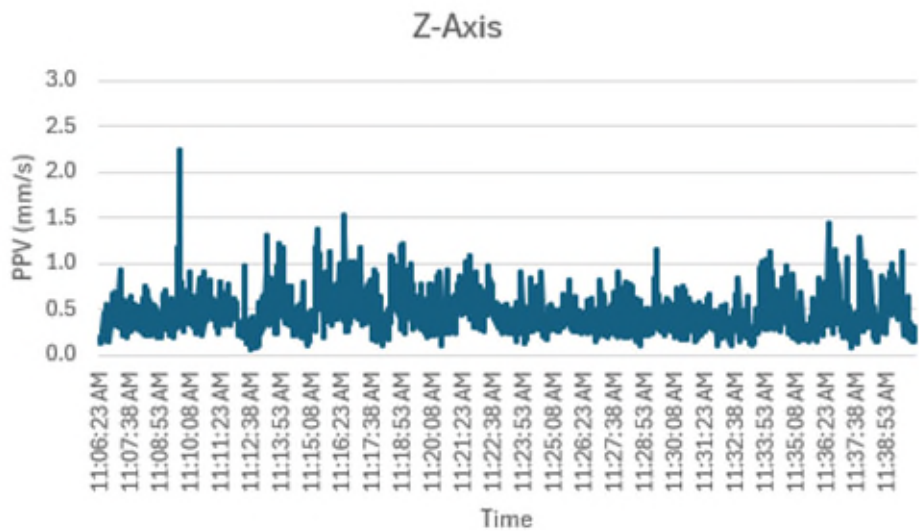
Figure B.3: 13.01.2025 measured vibration levels from all P01 works (X-Axis)

Date and Time	Distance (m)	Plant operating	Measured peak particle velocity (ppv), mm/s						Vibration criteria ppv (mm/s)
			X-axis		Y-axis		Z-axis		
			Frequency (Hz)	Maximum ppv	Frequency (Hz)	Maximum ppv	Frequency (Hz)	Maximum ppv	
M4									
07.01.2025	1-10m	Baseline vibration monitoring; pedestrian, car passby	-	0.49	-	1.02	-	0.79	5 mm/s 10 mm/s
M5									
13.01.2025 11:06am – 11:40am	3.5m	MRC 1.2t Bored piling rig	4	1.13	4	2.30	4	2.25	5 mm/s 10 mm/s

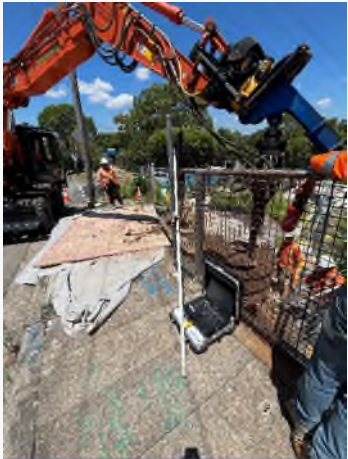
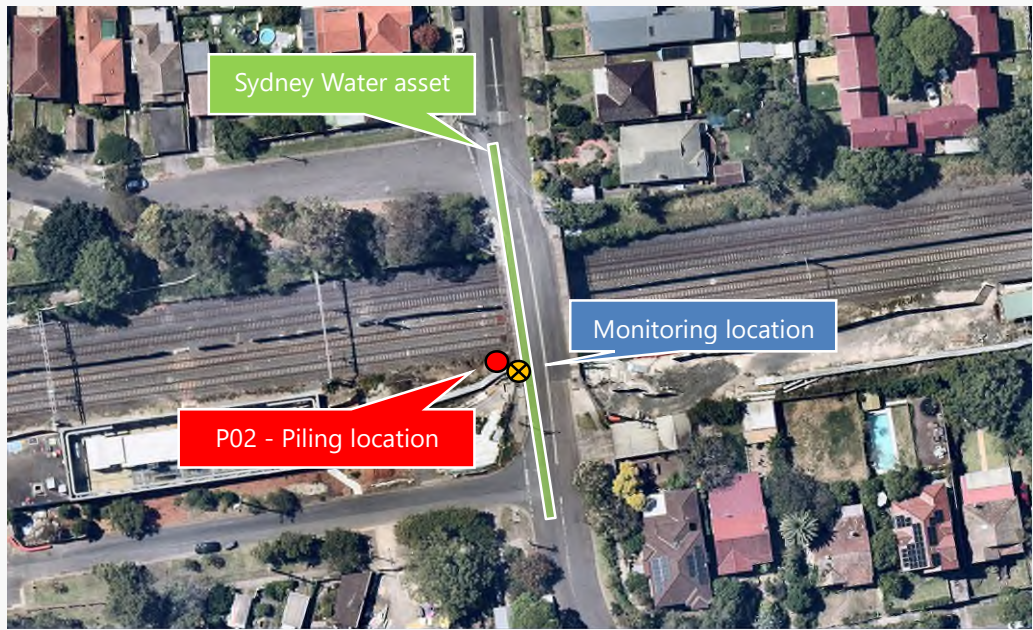
B.4 Melford Street Overbridge P02 piling works vibration monitoring

Vibration monitoring was conducted during the piling works on 13th January 2025. Based on the results below, the works produced vibration levels below the screening criterion of 5 mm/s at 2.5m away.

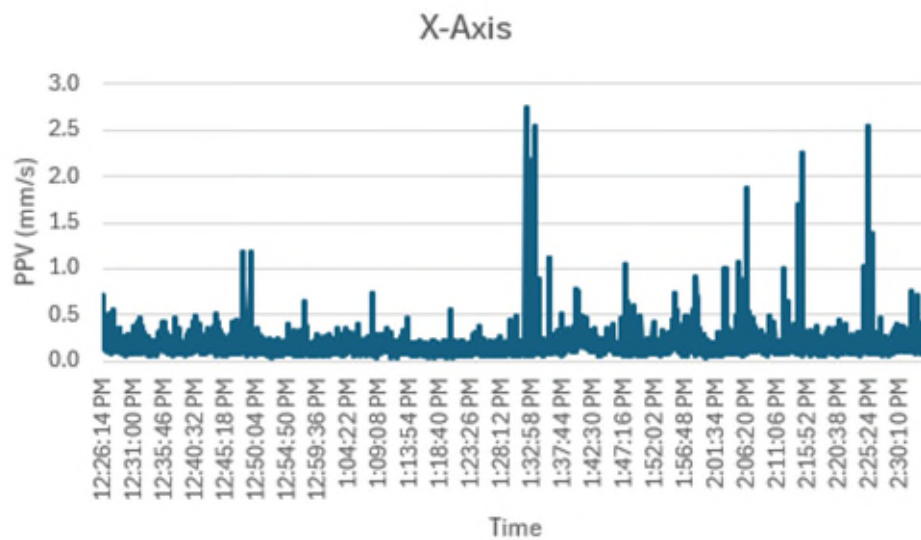
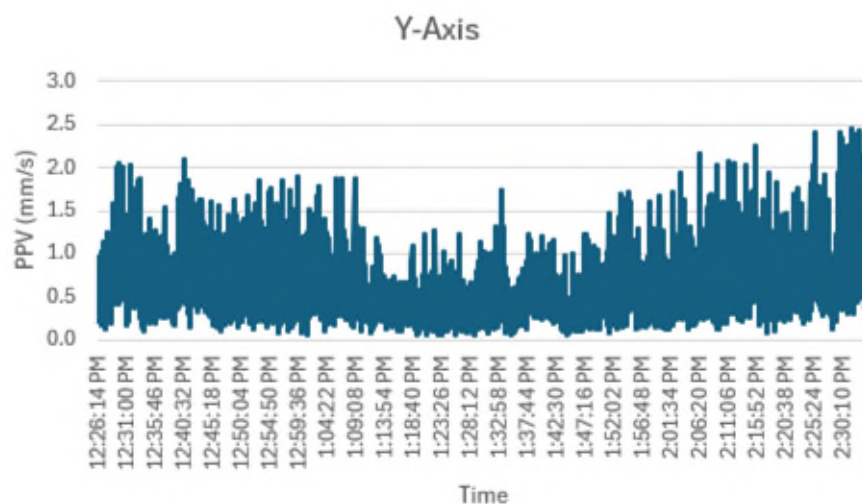
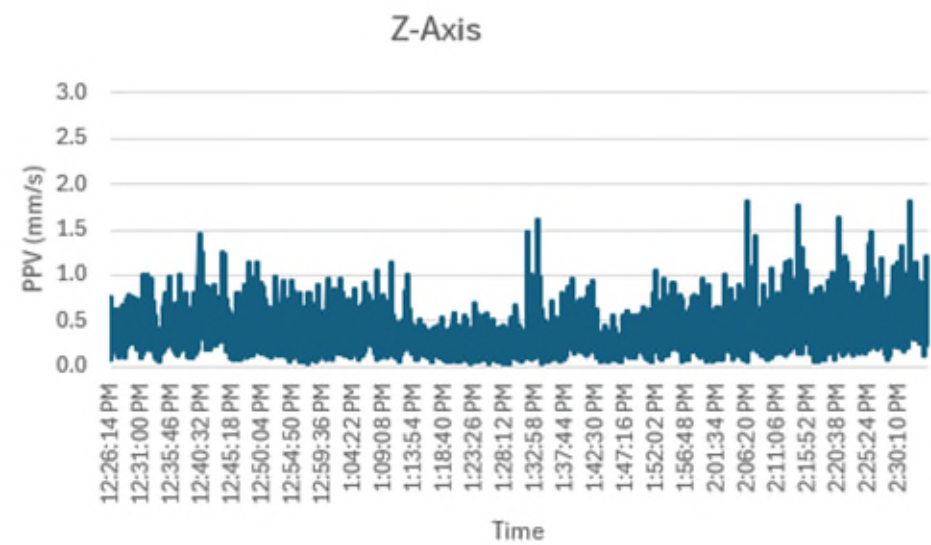
Figure B.4: 13.01.2025 measured vibration levels from all P02 works (X-Axis)

Date and Time	Distance (m)	Plant operating	Measured peak particle velocity (ppv), mm/s						Vibration criteria
			X-axis		Y-axis		Z-axis		
			Frequency (Hz)	Maximum ppv	Frequency (Hz)	Maximum ppv	Frequency (Hz)	Maximum ppv	ppv (mm/s)
M6									
13.01.2025 12:25pm – 02:46pm	2.5m	Zaxis 170W Excavator with drill attachment	4	2.75	4	2.45	4	1.81	5 mm/s 10 mm/s

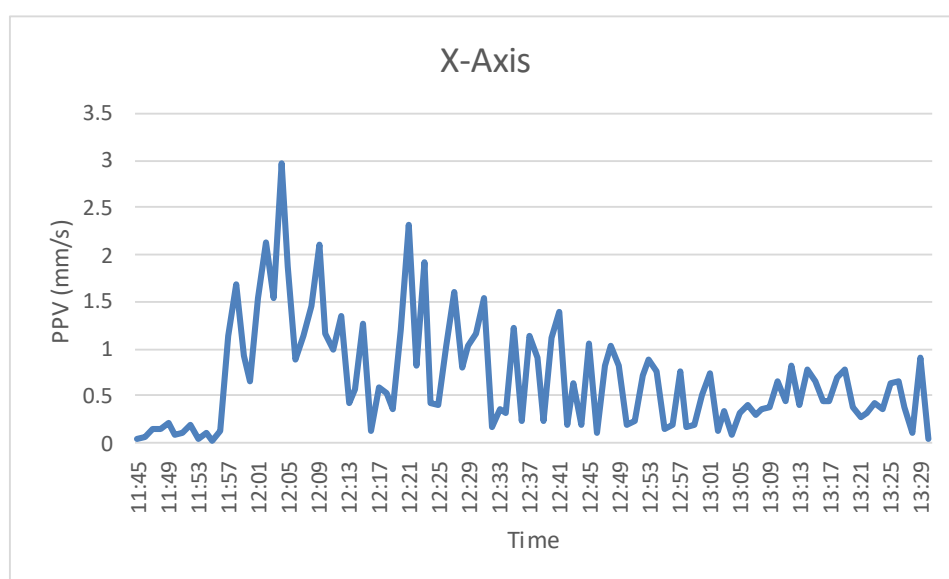
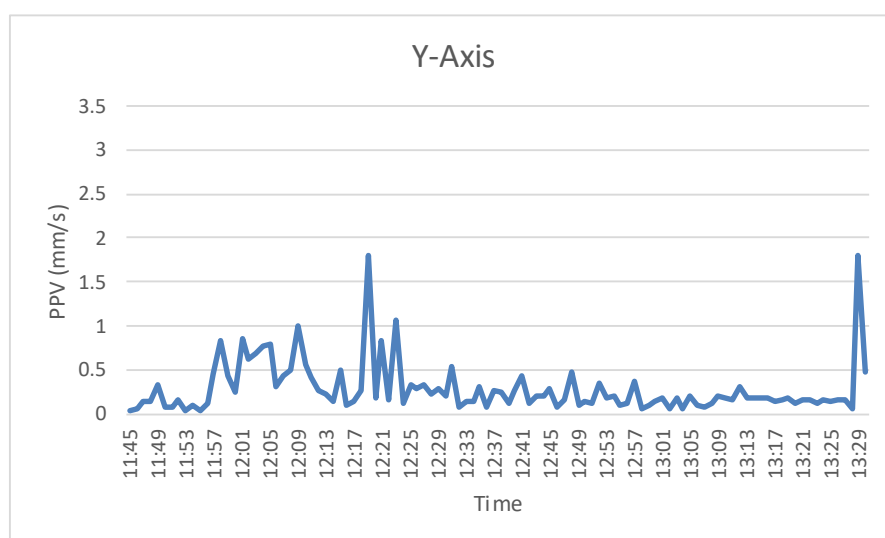
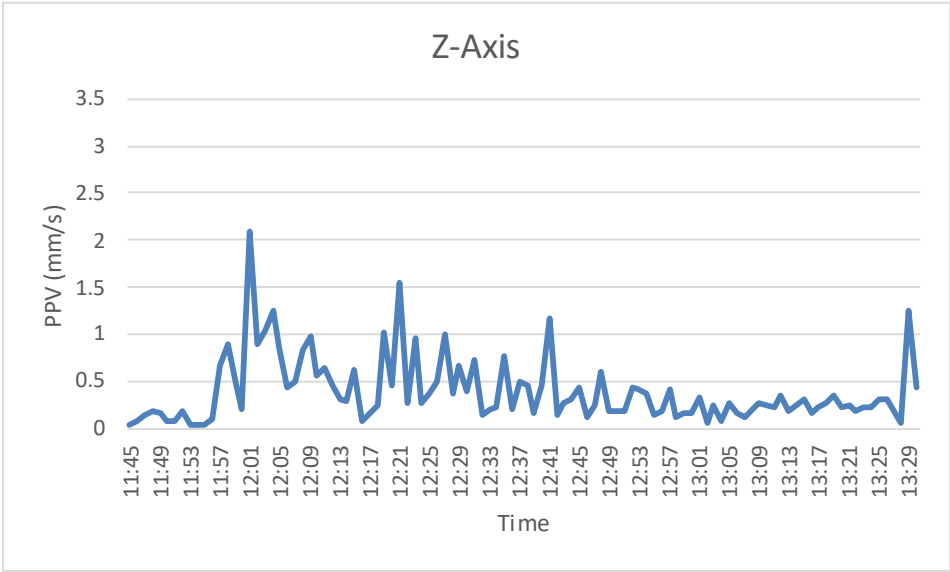
Figure B.5: 20.02.2025 measured vibration levels from piling works (X-Axis)

Date and Time	Distance (m)	Plant operating	Measured peak particle velocity (ppv), mm/s						Vibration criteria
			X-axis		Y-axis		Z-axis		
			Frequency (Hz)	Maximum ppv	Frequency (Hz)	Maximum ppv	Frequency (Hz)	Maximum ppv	ppv (mm/s)
M7									
20.02.2025 11:45am – 01:30pm	1m	MRC 1.2t bored piling rig	59	2.96	7	1.80	55	2.10	5 mm/s 10 mm/s

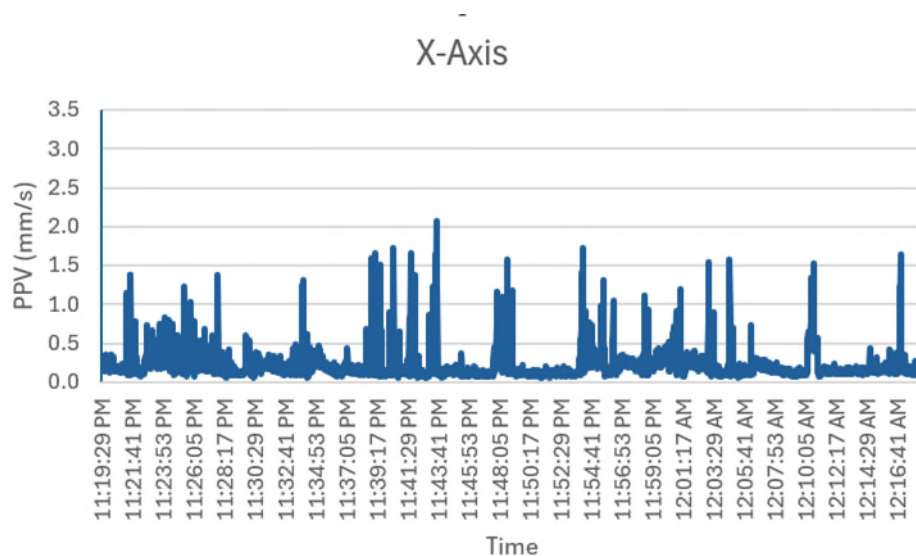
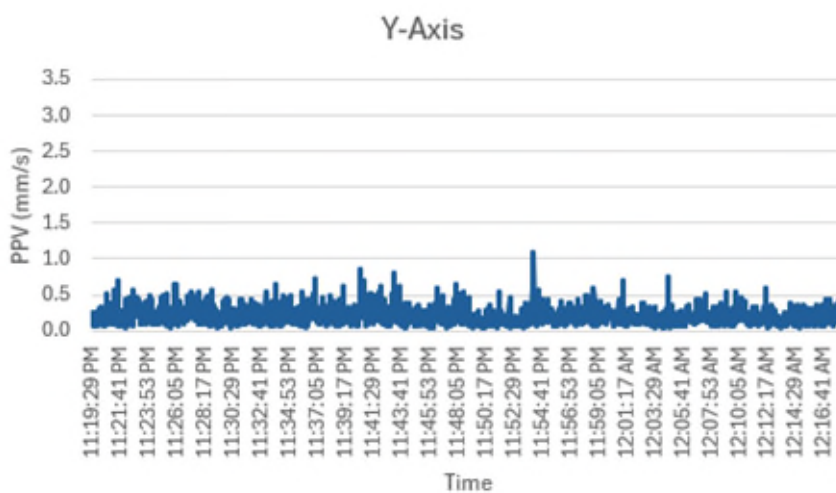
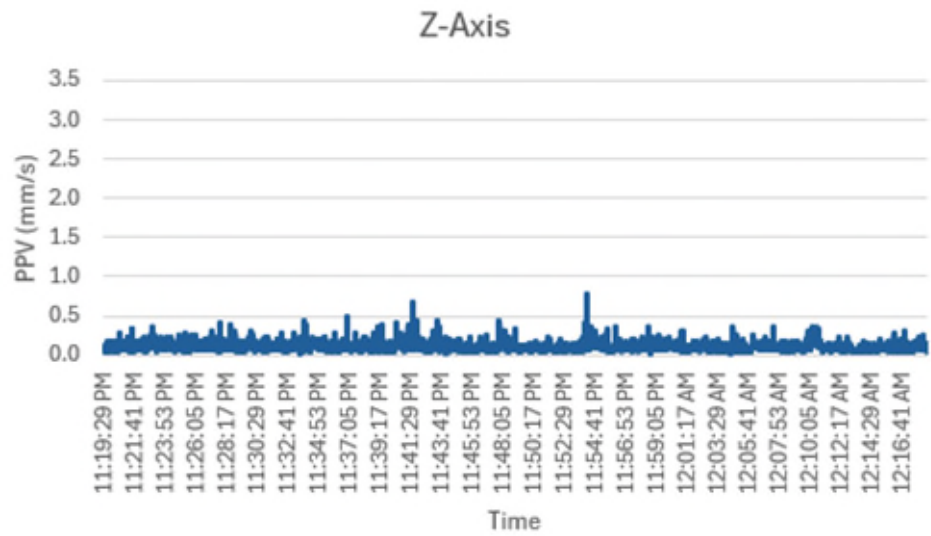
Figure B.6: 27.02.2025 measured vibration levels from piling works (X-Axis)

Date and Time	Distance (m)	Plant operating	Measured peak particle velocity (ppv), mm/s						Vibration criteria
			X-axis		Y-axis		Z-axis		
			Frequency (Hz)	Maximum ppv	Frequency (Hz)	Maximum ppv	Frequency (Hz)	Maximum ppv	ppv (mm/s)
M8									
27.02.2025 11:19pm – 12:21am	3m	MRC 1.2t bored piling rig	80	2.08	4	1.10	50	0.77	5 mm/s 10 mm/s

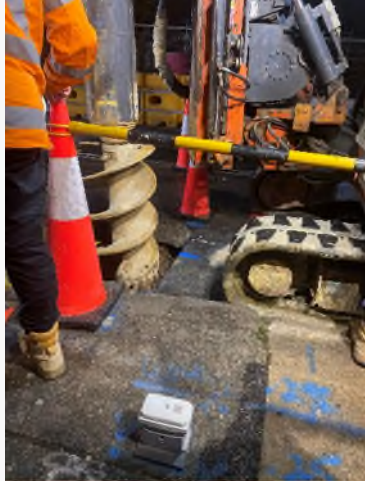
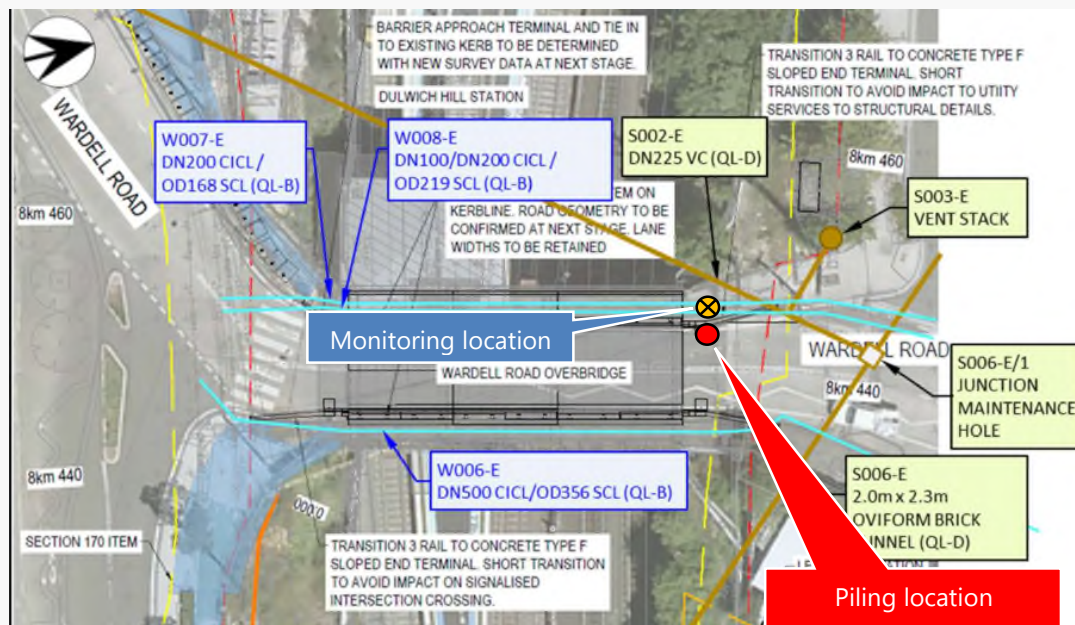
B.7 Wardell Road overbridge piling works vibration monitoring

Vibration monitoring was conducted during the piling works on 6th March 2025. Based on the results below, the works produced vibration levels below the screening criterion of 5 mm/s at 1m away.

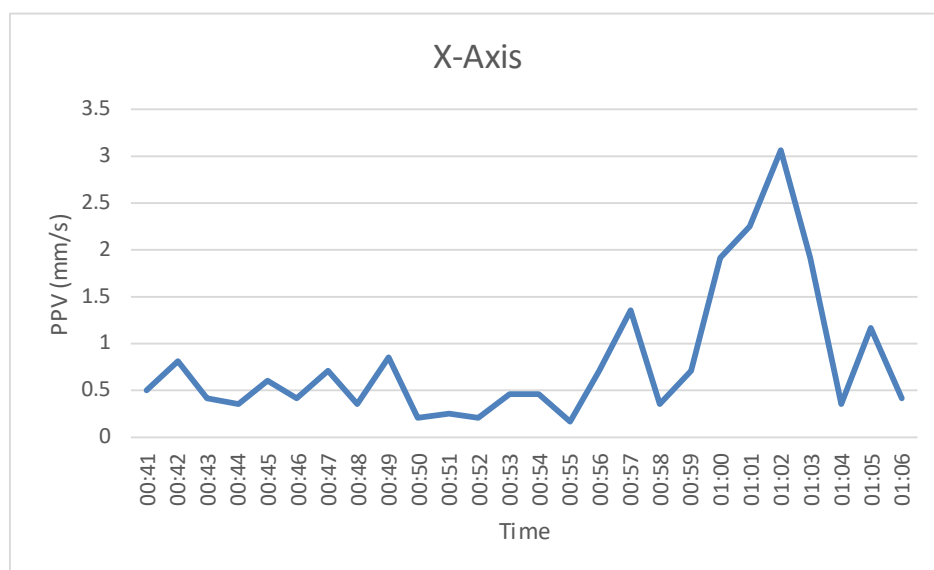
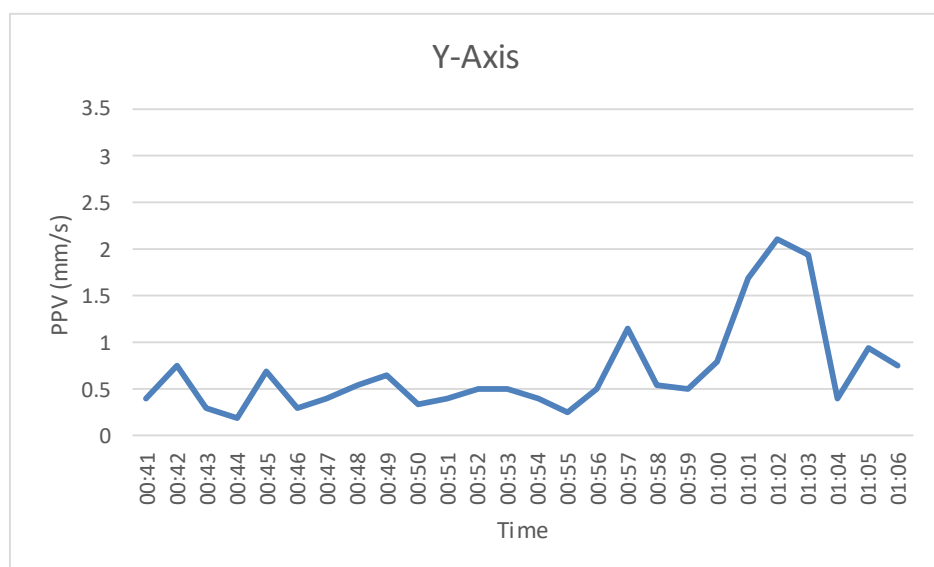
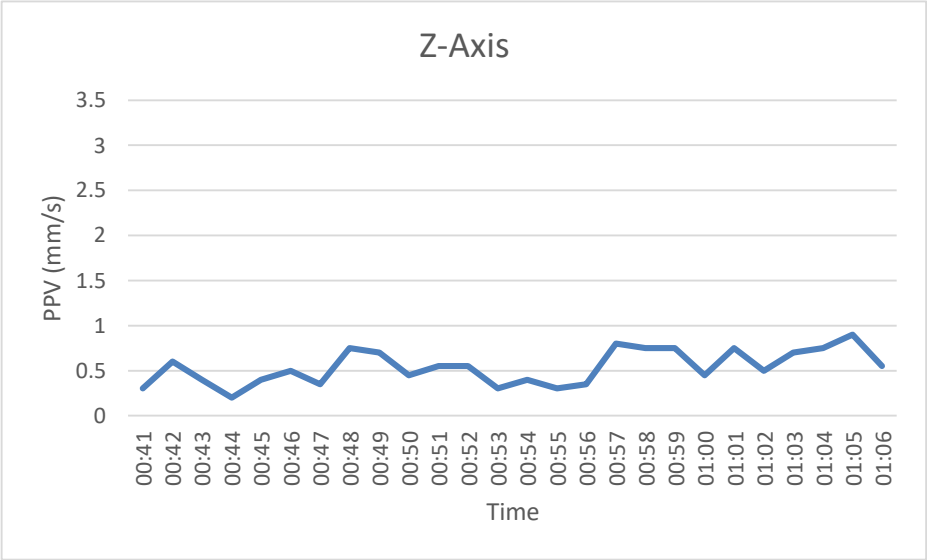
Figure B.7: 06.03.2025 measured vibration levels from piling works (X-Axis)

Date and Time	Distance (m)	Plant operating	Measured peak particle velocity (ppv), mm/s						Vibration criteria
			X-axis		Y-axis		Z-axis		
			Frequency (Hz)	Maximum ppv	Frequency (Hz)	Maximum ppv	Frequency (Hz)	Maximum ppv	ppv (mm/s)
M9									
06.03.2025 12:40am – 01:05am	1m	MRC 1.2t bored piling rig	158	3.05	85	2.10	108	0.90	5 mm/s 10 mm/s

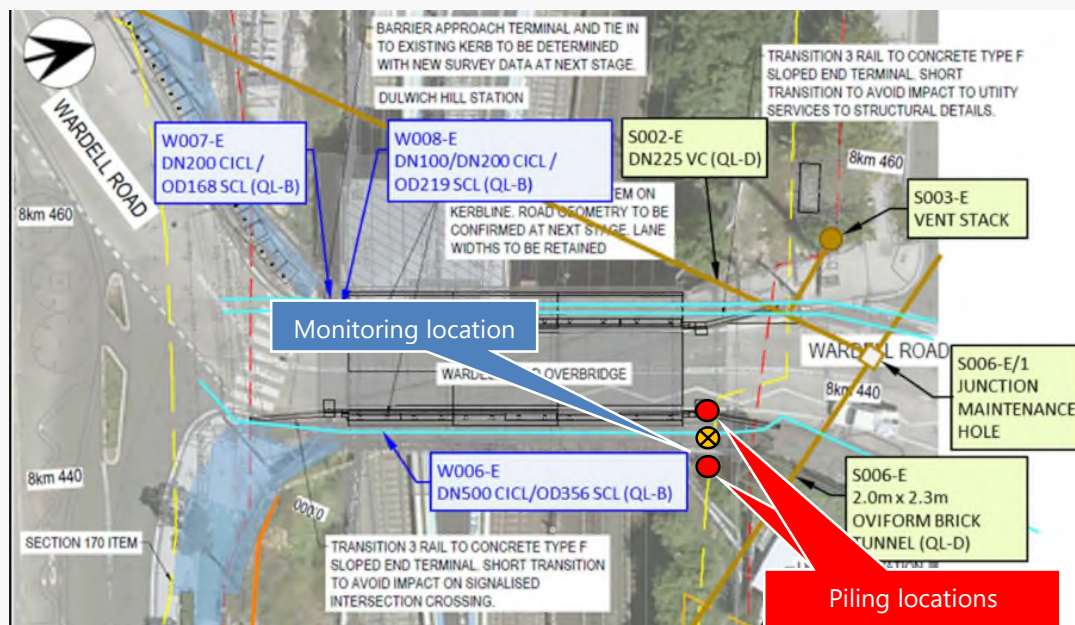
B.8 Wardell Road overbridge piling works vibration monitoring

Vibration monitoring was conducted during the piling works on 6th March 2025. Based on the results below, the works produced vibration levels below the screening criterion of 5 mm/s at 1.5m and 2m away.

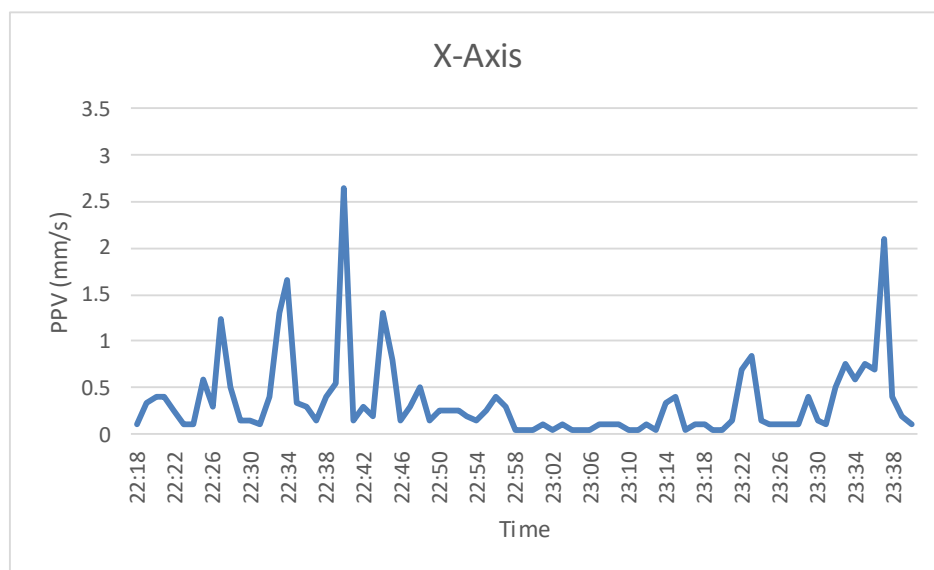
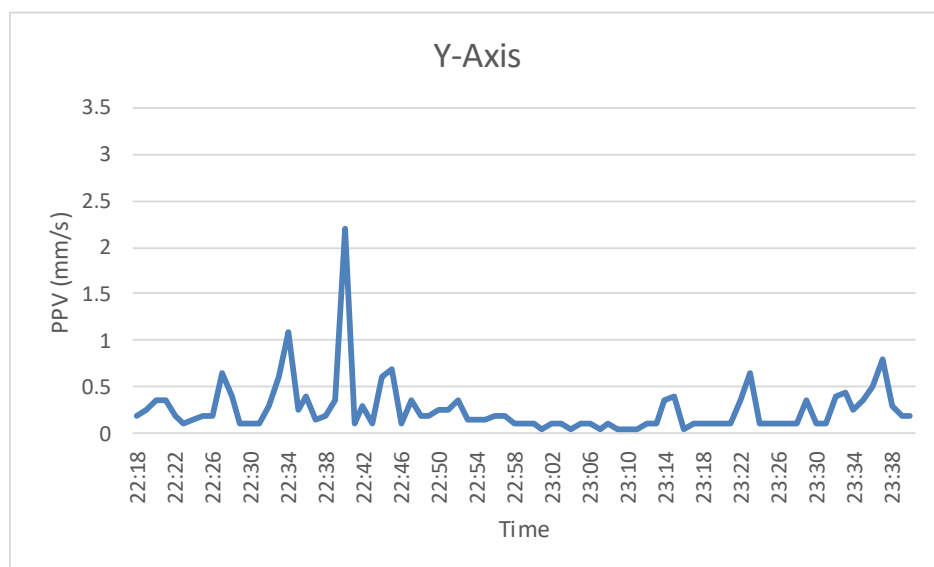
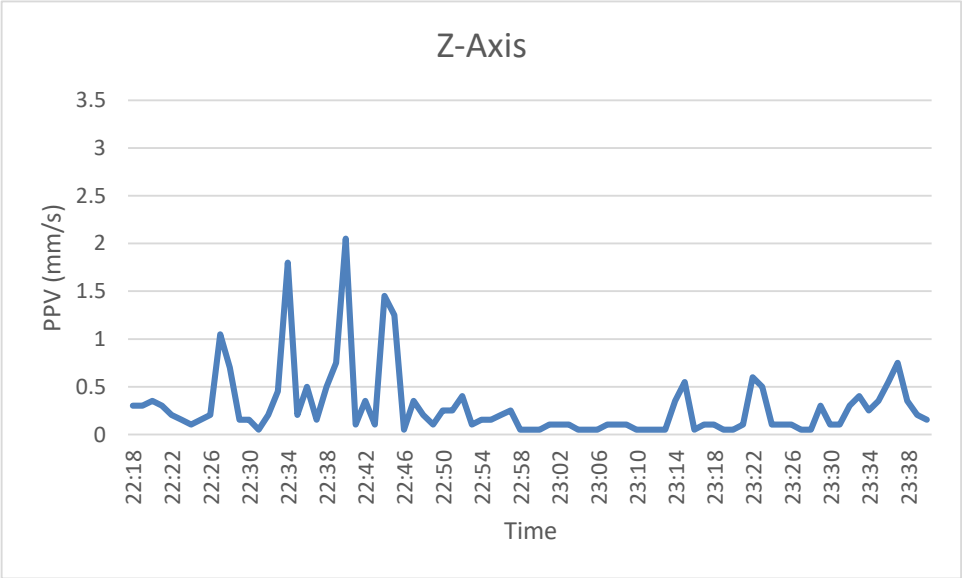
Figure B.8: 06.03.2025 measured vibration levels from piling works (X-Axis)

Figure B.8: 06.03.2025 measured vibration levels from piling works (Y-Axis)

Figure B.8: 06.03.2025 measured vibration levels from piling works (Z-Axis)

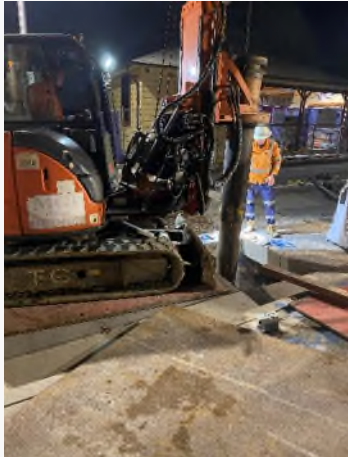
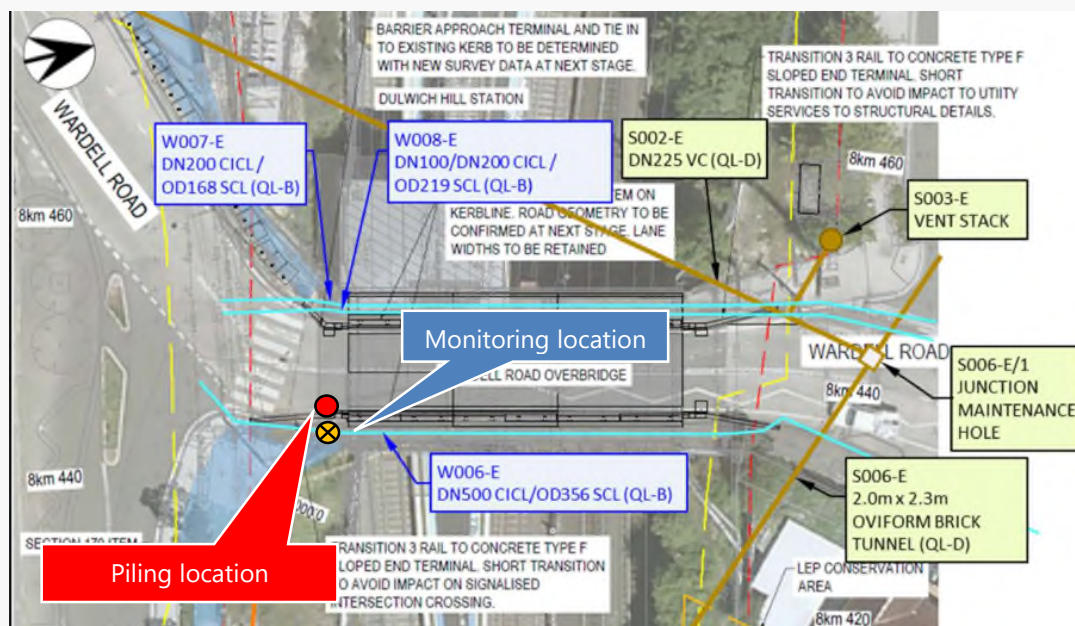
Measurement ID:	M11	
Assessment point:	In-line with W006-E DN500 CICL/OD356 SCL

Date:	06.03.2025
	Measurement type:	Vibration
	Meas. location:	In-line with W006-E DN500 CICL/OD356 SCL
	Measured distance:	1.m
	Geology:	Piling works undertaken on soft rock
	Plant	MRC 1.2t bored piling rig
	Instrumentation:	Sigicom C22 (SN: #116242)
	Notes	Monitor located on surface above the W006-E DN500 CICL/OD356 SCL Sydney Water asset, approximately 1m from the works.

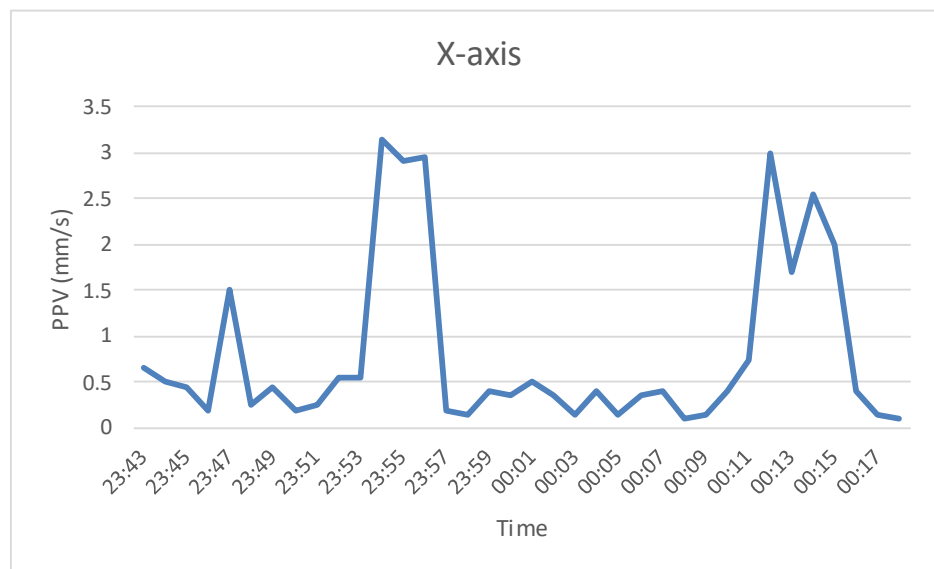
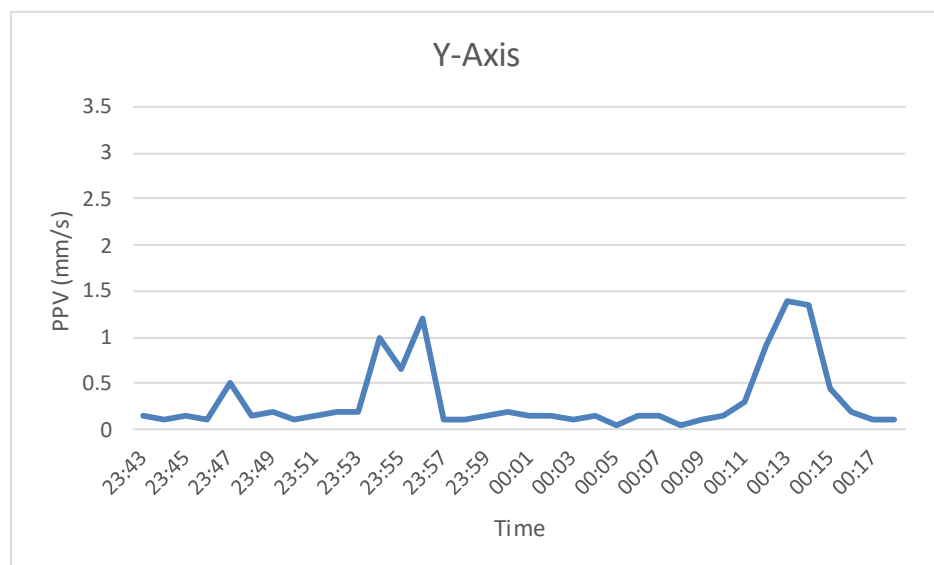
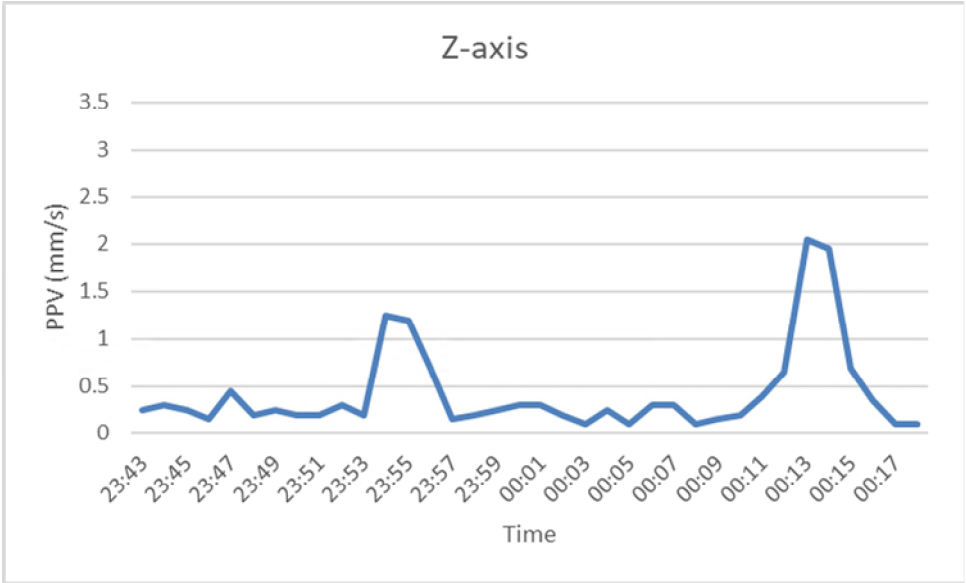
Vibration monitoring was conducted during the piling works on 6th March 2025. Based on the results below, the works produced vibration levels below the screening criterion of 5 mm/s at 1m away.

Figure B.9: 06.03.2025 measured vibration levels from piling works (X-Axis)

Figure B.9: 06.03.2025 measured vibration levels from piling works (Y-Axis)

Figure B.9: 06.03.2025 measured vibration levels from piling works (Z-Axis)

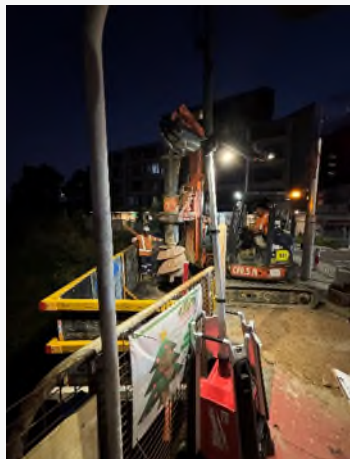
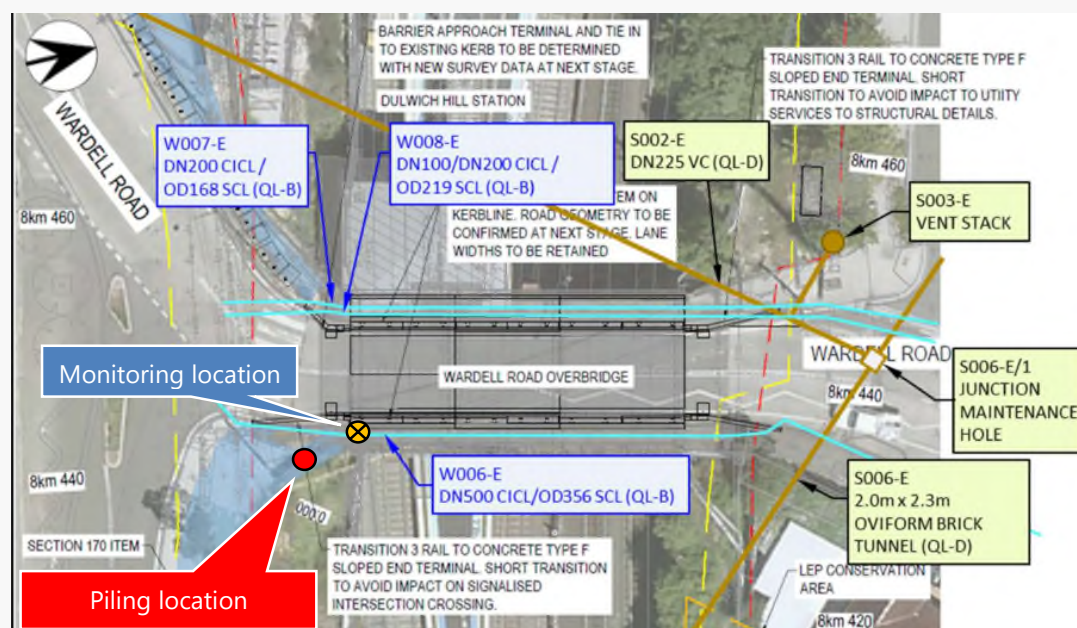
Measurement ID:	M12	
Assessment point:	In-line with W006-E DN500 CICL/OD356 SCL

Date:	07.03.2025
	Measurement type:	Vibration
	Meas. location:	In-line with W006-E DN500 CICL/OD356 SCL
	Measured distance:	4m
	Geology:	Piling works undertaken on soft rock
	Plant	MRC 1.2t bored piling rig
	Instrumentation:	Sinus Soundbook-1 + B&K Type 4524B (SN: 39142)
	Notes	Monitor located on surface above the W006-E DN500 CICL/OD356 SCL Sydney Water asset, approximately 4m from the works.
