CONSTRUCTION MONITORING REPORT

[OCTOBER 2024 TO APRIL 2025]

Errant and Hostile Vehicle Mitigation
Treatments for the Southwest Metro Project
SMC-22-0722

SMCSWSW7-MRL-1NL-
EM-REP-001090

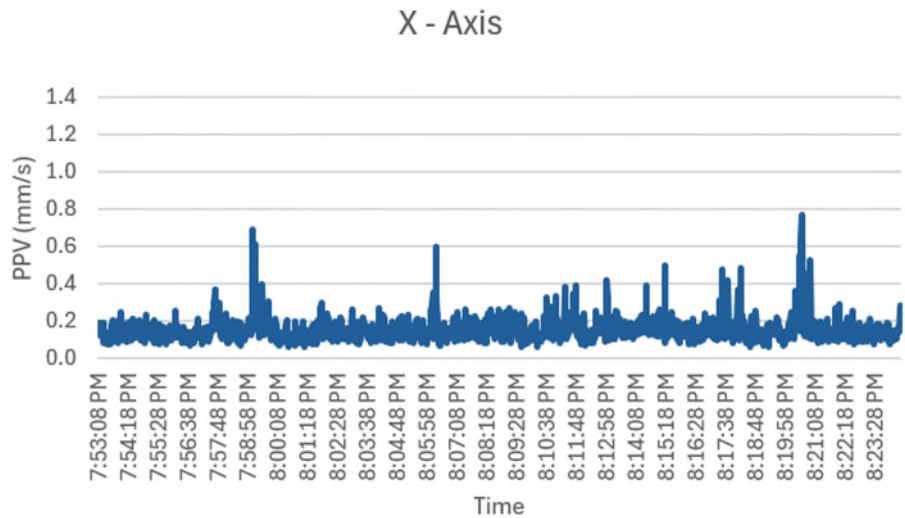
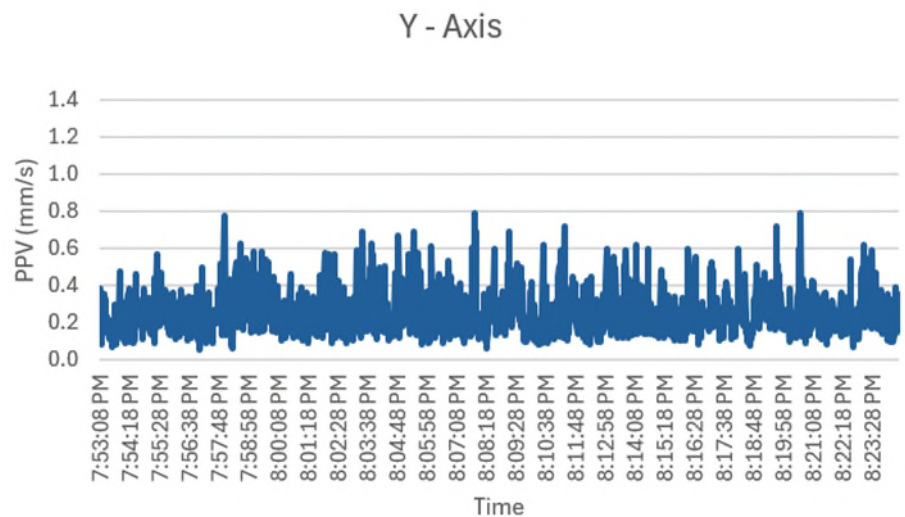
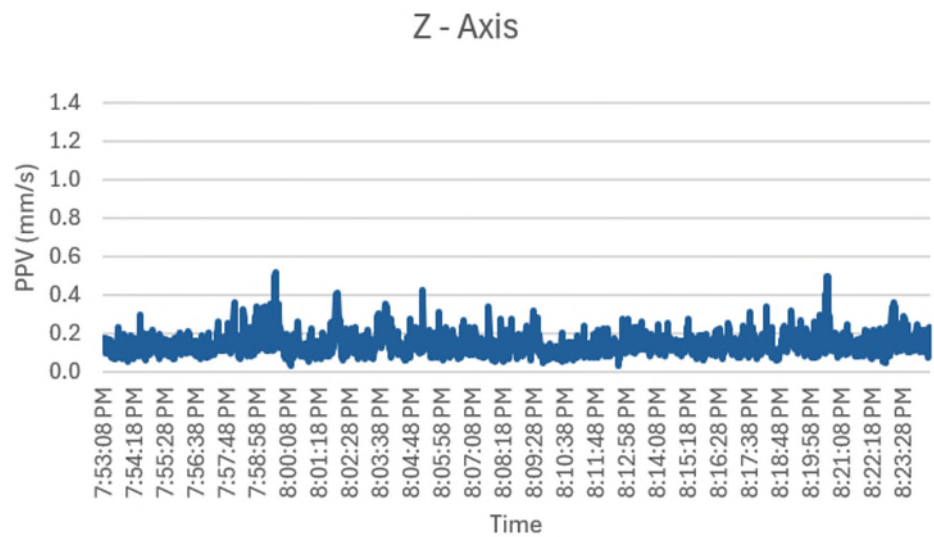
Vibration monitoring was conducted during the piling works on 7th March 2025. Based on the results below, the works produced vibration levels below the screening criterion of 5 mm/s at 4m away.

Figure B.10: 07.03.2025 measured vibration levels from piling works (X-Axis)

Figure B.10: 07.03.2025 measured vibration levels from piling works (Y-Axis)

Figure B.10: 07.03.2025 measured vibration levels from piling works (Z-Axis)

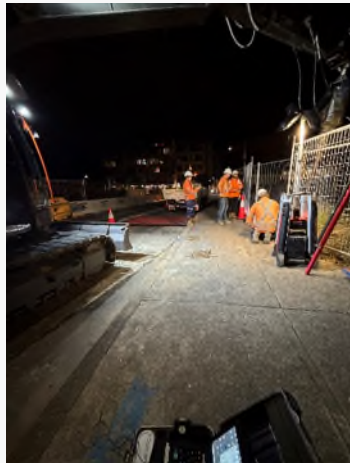
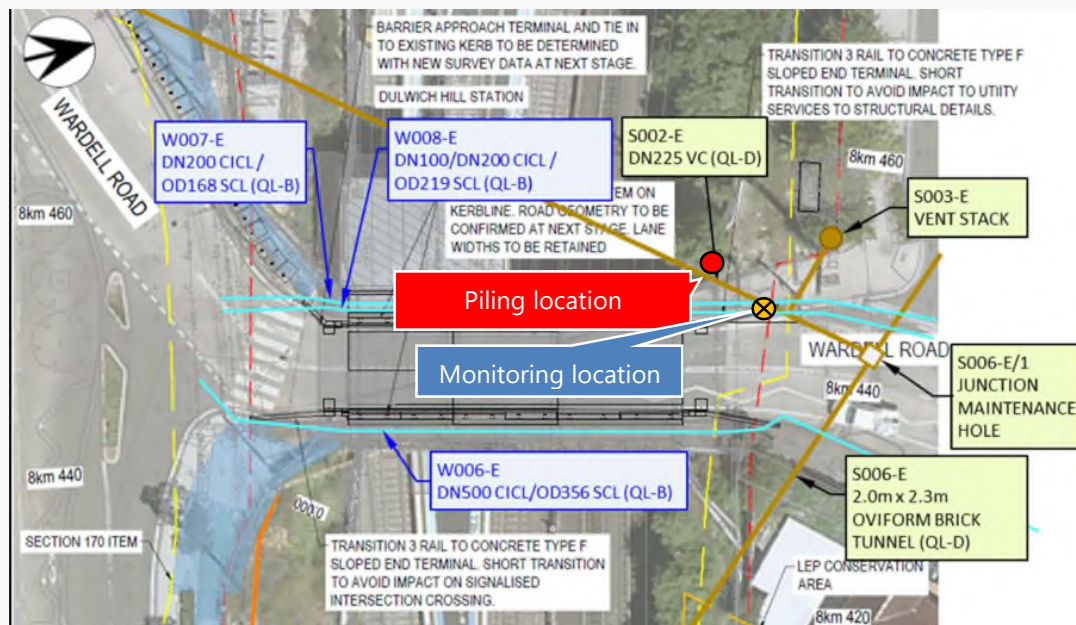
Measurement ID:	M13	
Assessment point:	In-line with W007-E DN200 CICL/OD168 SCL and W008-E DN100/DN200 CICL/ OD219 SCL

Date:	07.03.2025
	Measurement type:	Vibration
	Meas. location:	In-line with W007-E DN200 CICL/OD168 SCL and W008-E DN100/DN200 CICL/ OD219 SCL
	Measured distance:	5m
	Geology:	Piling works undertaken on soft rock
	Plant	14t excavator with auger attachment
	Instrumentation:	Sinus Soundbook-1 + B&K Type 4524B (SN: 39142)
Notes	Monitor located on surface above the W007-E DN200 CICL/OD168 SCL and W008-E DN100/DN200 CICL/ OD219 SCL Sydney Water asset, approximately 5m from the works. This measuring point is also assessing S002-E DN225 VC, S003-E Vent Stack and S006-E/1 Junction Maintenance Hole assets.

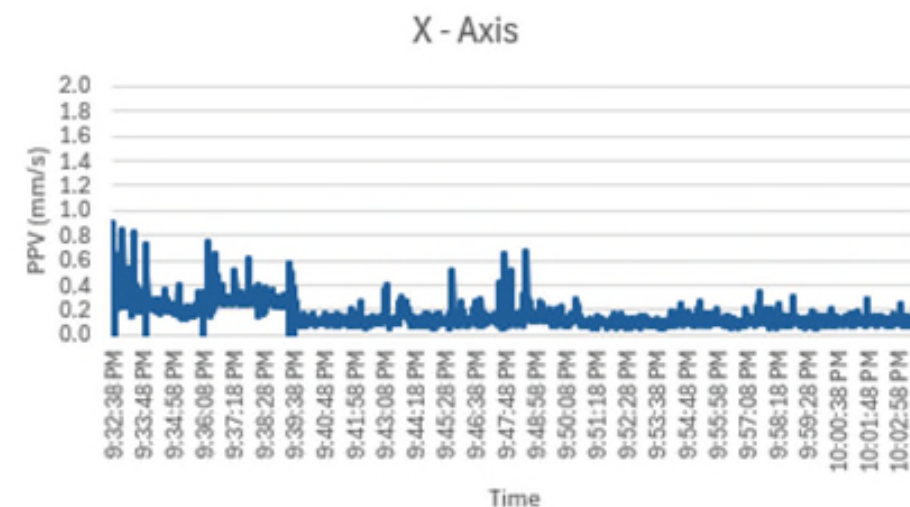
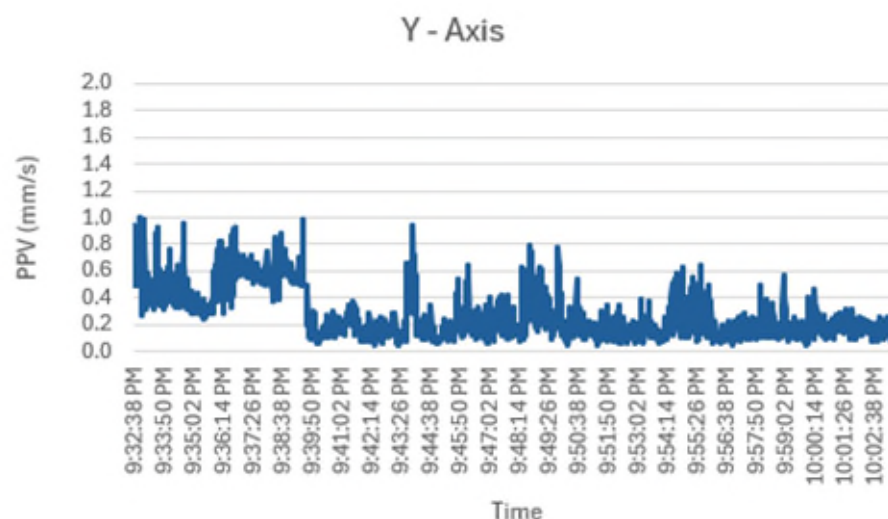
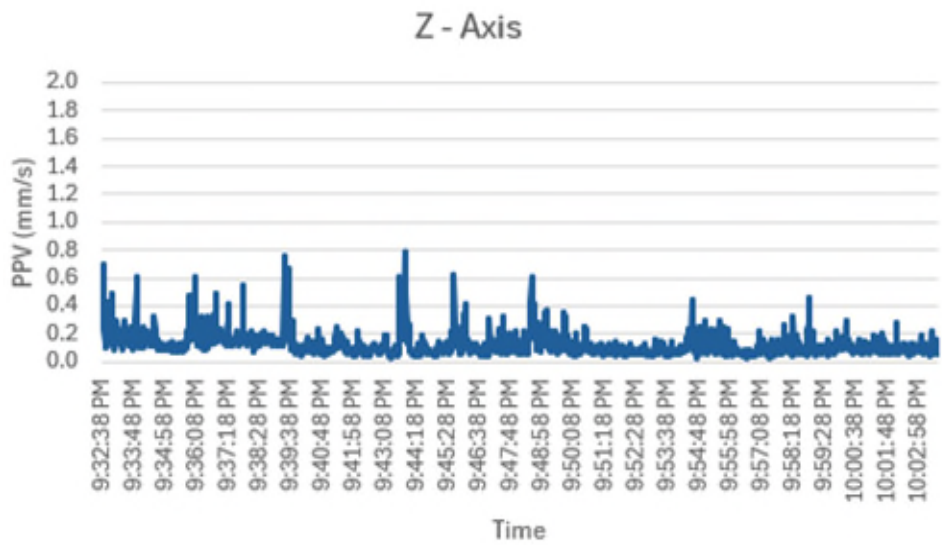
Vibration monitoring was conducted during the piling works on 7th March 2025. Based on the results below, the works produced vibration levels below the screening criterion of 5 mm/s at 5m away.

Figure B.11: 07.03.2025 measured vibration levels from piling works (X-Axis)

Figure B.11: 07.03.2025 measured vibration levels from piling works (Y-Axis)

Figure B.11: 07.03.2025 measured vibration levels from piling works (Z-Axis)

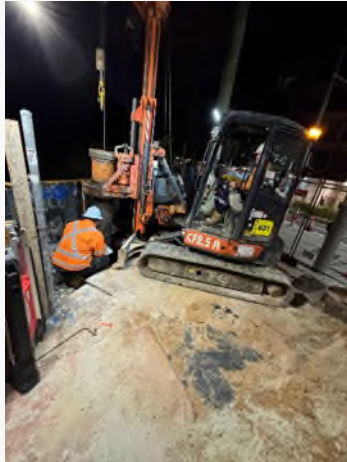
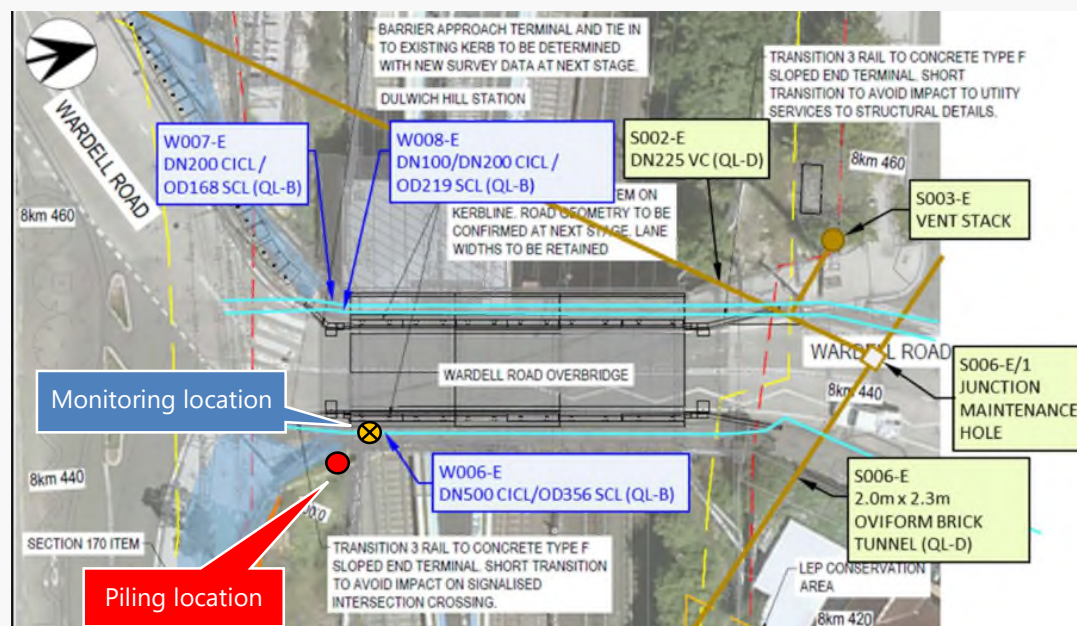
Measurement ID:	M14
Assessment point:	In-line with W006-E DN500 CICL/OD356 SCL
Date:	07.03.2025
Measurement type:	Vibration
Meas. location:	In-line with W006-E DN500 CICL/OD356 SCL
Measured distance:	3.5m
Geology:	Piling works undertaken on soft rock
Plant	MRC 1.2t bored piling rig
Instrumentation:	Sinus Soundbook-1 + B&K Type 4524B (SN: 39142)
Notes	Monitor located on surface above the W006-E DN500 CICL/OD356 SCL Sydney Water asset, approximately 3.5m from the works.

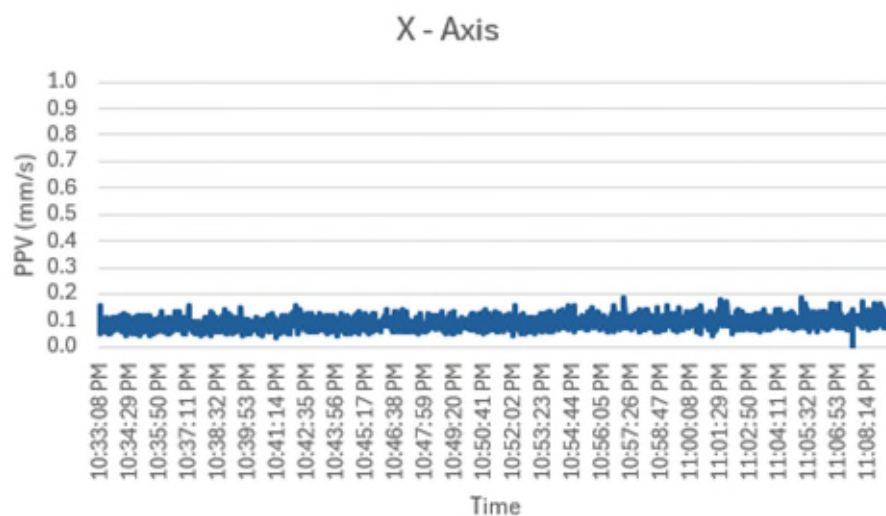
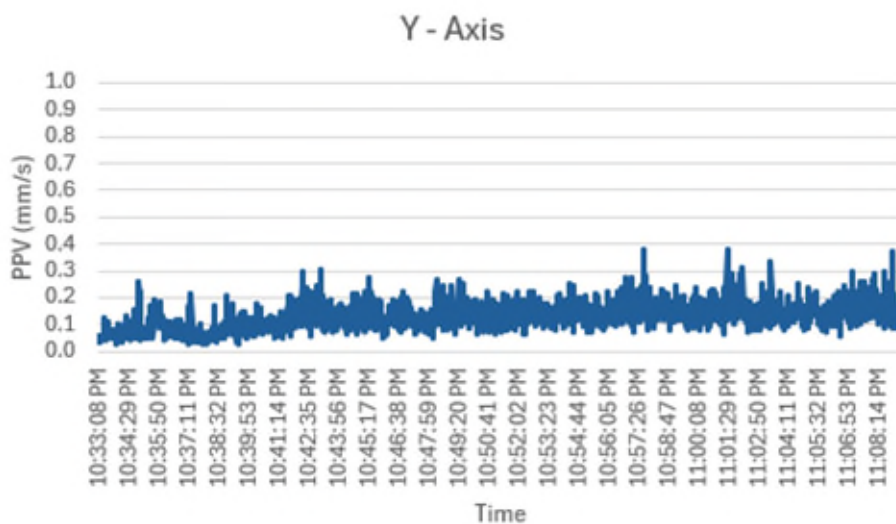
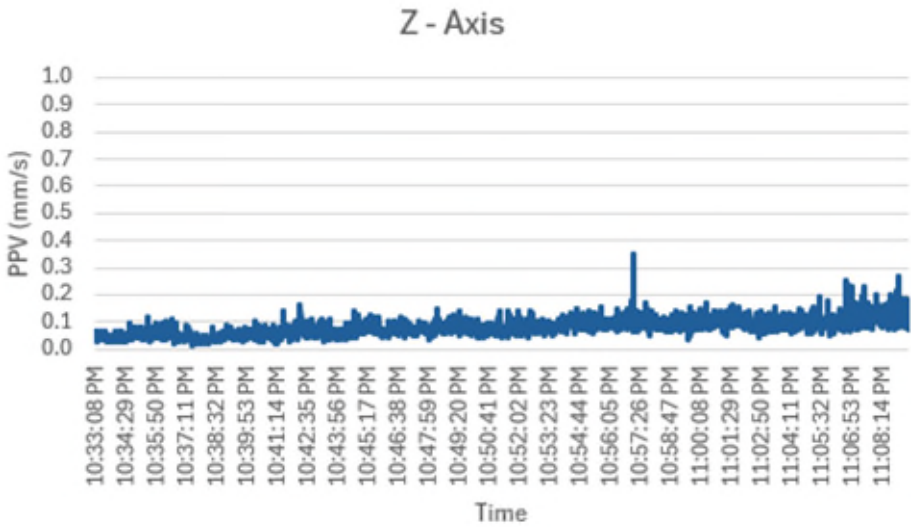
Vibration monitoring was conducted during the piling works on 7th March 2025. Based on the results below, the works produced vibration levels below the screening criterion of 5 mm/s at 3.5m away.

Figure B.12: 07.03.2025 measured vibration levels from piling works (X-Axis)

Figure B.12: 07.03.2025 measured vibration levels from piling works (Y-Axis)

Figure B.12: 07.03.2025 measured vibration levels from piling works (Z-Axis)
